**Aviation Safety Council  
Taipei, Taiwan**

**GE235 Occurrence Investigation  
Factual Data Collection  
Group Report**

**Airworthiness Group**

**ASC-FRP-15-07-003**

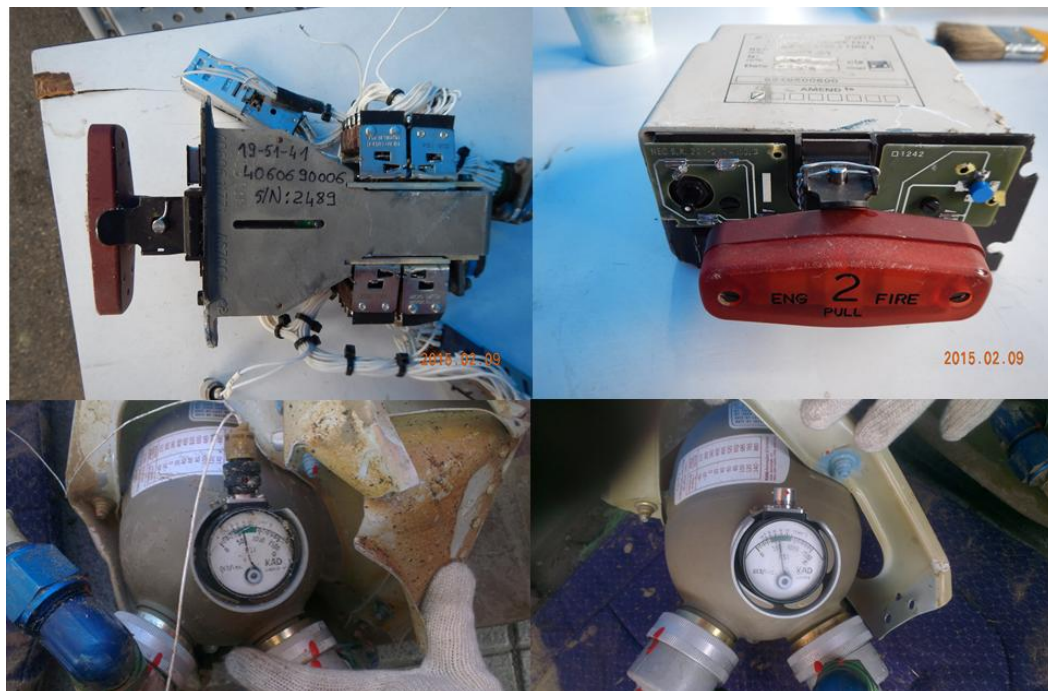
Figure 1.6-3 No. 1, 2 fire handles and fire bottles

When the fire handle is pulled, feathering is performed identical to that of the automatic feathering system. Upper two photos of Figure 1.6-3 show that both safety wires of No. 1 and No. 2 fire handles are secured in place. Lower two photos of Figure 1.6-3 show the pointers of two fire bottle pressure gages are in the green ranges.

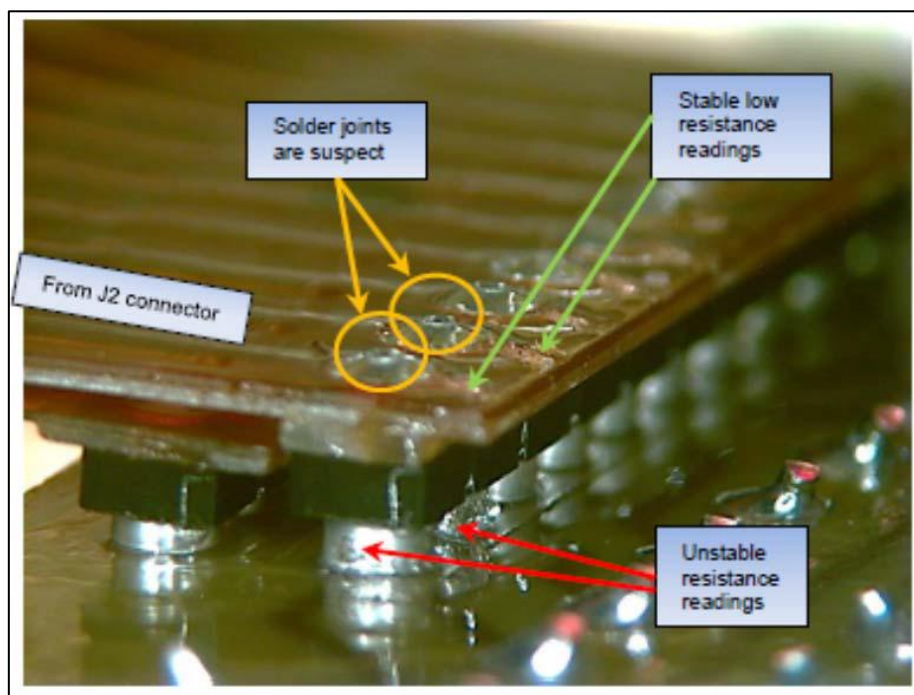
Figure 1.16-2 Continuity check of pin J and A2 board

AFU No. 2 failed to pass continuity test. The measured resistances values for the Pins J and H were fluctuated from 1 to 20 ohms when the ribbon was moved by hand. The resistance was higher than the CMM (Component Maintenance Manual with Illustrated Parts List, 73-20-03, Rev. 11, Oct 01, 2014) values threshold of 0.35 ohms for the Pins J and H. These two pins are the pins connected with the torque sensor. An X-ray examination was performed and no defect was found of this unit. In order to find where the increased resistance occurred between Pin J/H of J2 connector and the A2 board strip contact (contact points No. 34/33), a new test procedure was proposed and agreed by all attendees for this unit.

- The resistance ( $R_{X1}$ ) measured between pin J and point X1 provided a value consistent with the maximum resistance value provided by the CMM. Moving the ribbon did not affect this value.
- The resistance ( $R_{X2}$ ) measured between pin J and point X2 provided a value greater than  $R_{X1}$ , which was unstable and changed while the ribbon was moved.
- The resistance ( $R_{X3}$ ) measured between pin J and point X3 provided a value greater than  $R_{X1}$ , which was unstable and changed while the ribbon was moved.

It was noted that the first time  $R_{J2}$  and  $R_{H2}$  were measured, both were unstable. As the tests were repeated, from time to time,  $R_{J2}$  and/or  $R_{H2}$  were stable during one test. The continuity failures detected on pin H and pin J were located inside the header strip connector (end of the ribbon, opposite to the J2 socket). The discontinuity was observed to be intermittent. The test results are summarized in Table 1.16-3.

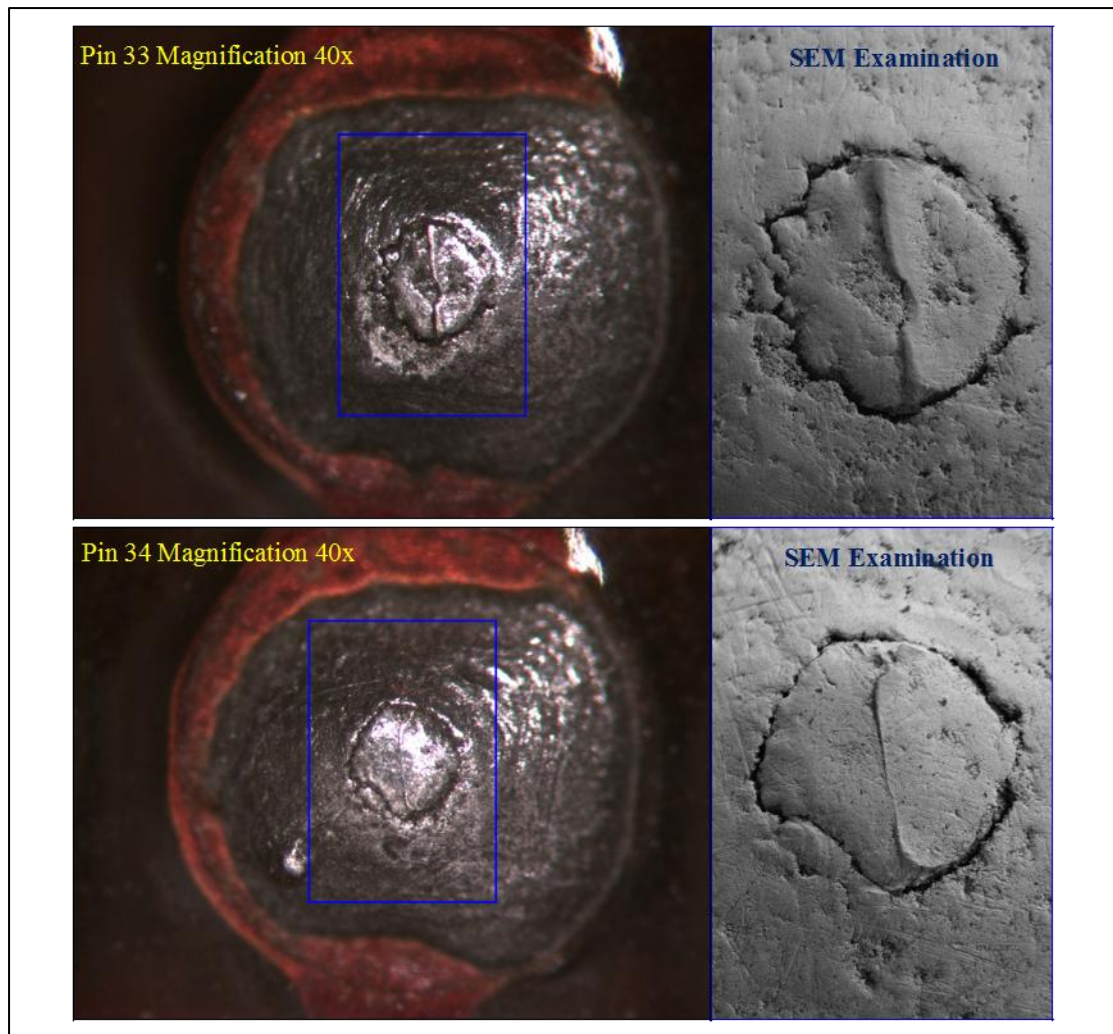
Figure 1.16-3 Pins 33 and 34 with 40X magnifications and with SEM

A CT-Scan (Computed Tomography) of J2 solder joints was performed and potential solder cracking was identified. A destructive test was performed to find the possible root cause of continuity failures inside the 90°connector of J2 flex circuit. The J2 flex circuit was cut out of the CCA (Circuit Card Assembly) and housing. Pins 33-42 of J2 flex circuit was examined using optical microscope and with the SEM (Scanning Electron Microscope). Figure 1.16-3 shows the photos of Pins 33 and 34 with 40X magnifications and with SEM examination. The Pins 33-42 of J2 flex circuit was cross sectioned to the component centerline and examined. Figure 1.16-4 and 1.16-5 show the photos of cross sectioned pin to flex solder joints of Pins 33 and 34. The Pin-Flex solder joints displayed a coursing of the solder micro structure near the pin on each of the 10 pins in the strip. The condition was most advanced on pins near the end of the strip. In the optical cross-section images the Lead-rich phase are the grey particles dispersed within the white Tin-rich phase. In the SEM images the Lead phase is white and Tin is grey. The solder microstructure is enlarging, coarsening and cracking in a stress zone adjacent to the Pin / Solder interface. Away from this “crack zone” the solder microstructure is very fine.

- Continuity failures (resistance values above the CMM threshold) exist between pin H and the circuit board, and between pin J and the circuit board
- Continuity failures (resistance values above the CMM threshold) are located at the solder joint interface between the flex circuit and the header pin
- Continuity failures (resistance values above the CMM threshold) were inconstant
- The solder microstructure is enlarging, coarsening and cracking in a stress zone adjacent to the solder joint interface between the flex circuit and the header pin

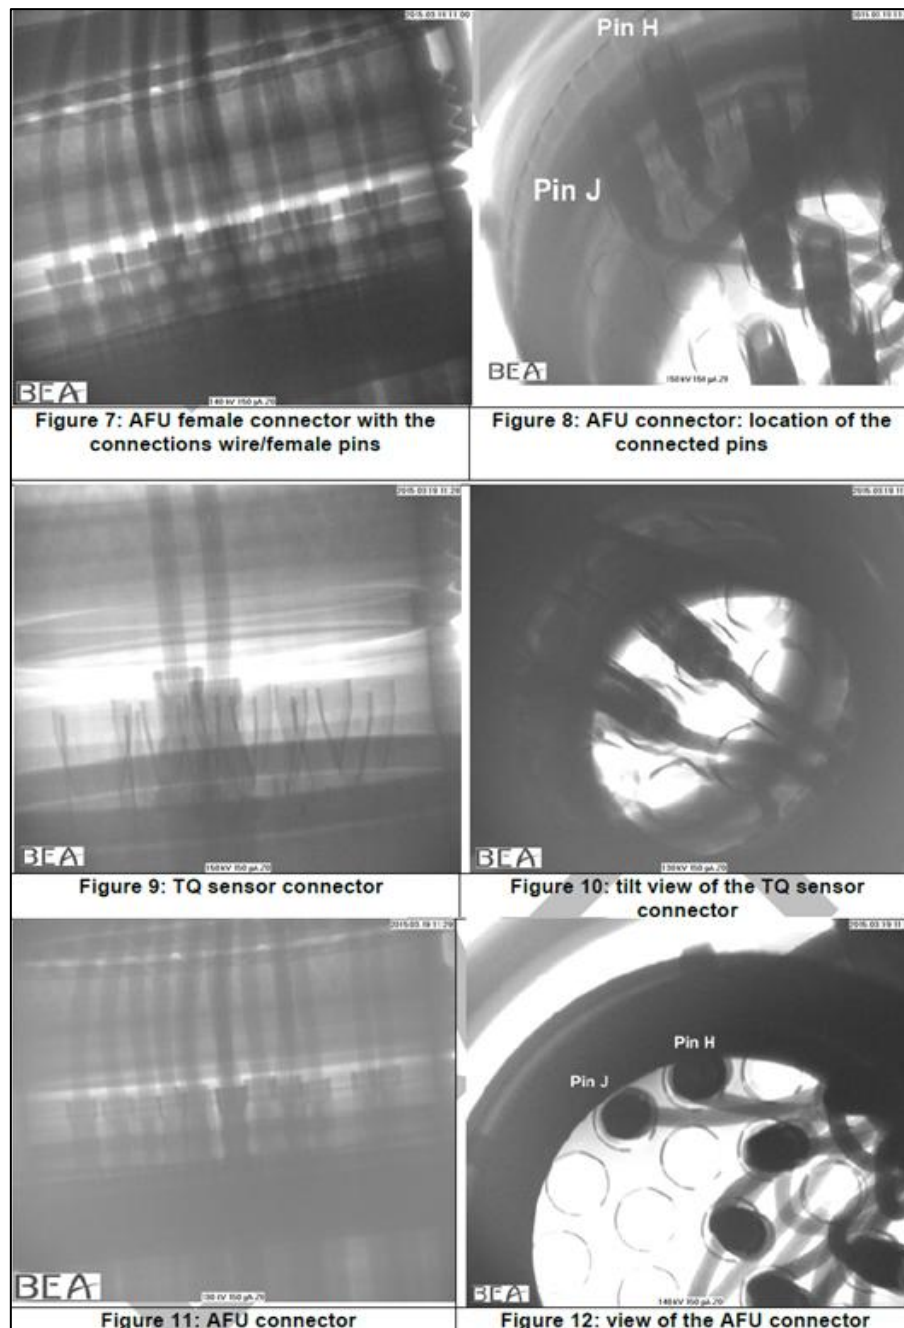
Figure 1.16-7 X-ray examination of AFU and torque sensor connectors

The X-ray examination of both harnesses showed no anomaly. The X-ray pictures of the connectors which connect AFU and the torque sensor of No. 2 engine are shown in Figure 1.16-7.

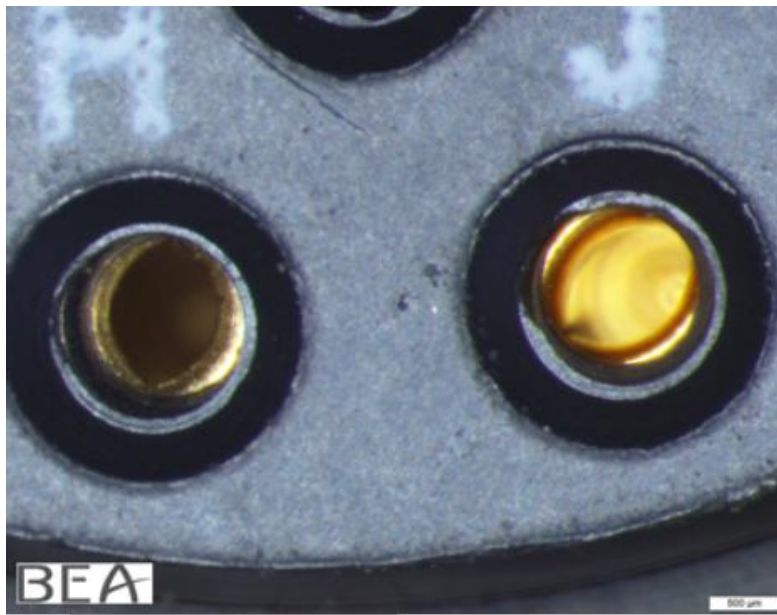
Figure 1.16-8 Pins H and J of No. 2 AFU connector

The macroscopic examination showed a difference between the pin H of AFU connector of No.2 engine and the other pins on this connector. A picture of pins H, J of No. 2 AFU connector is shown in Figure 1.16-8.

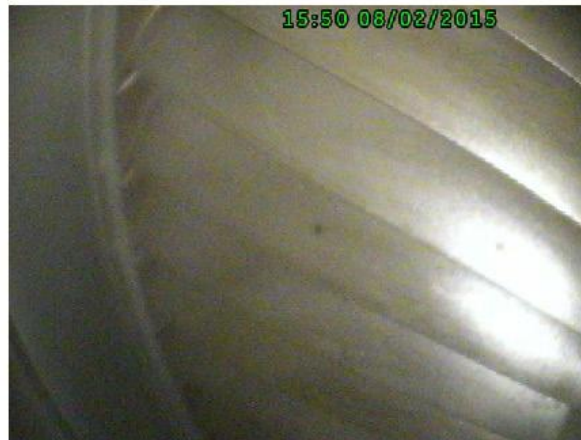
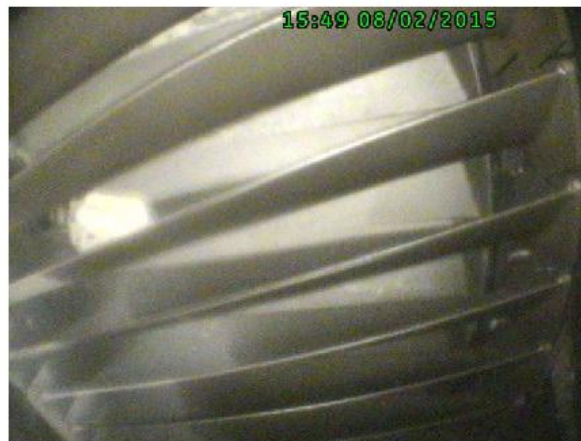
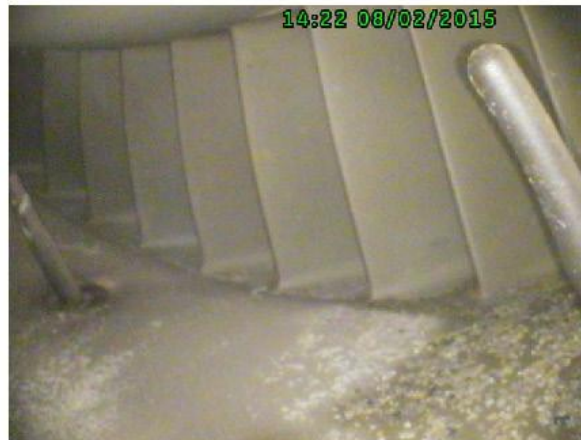
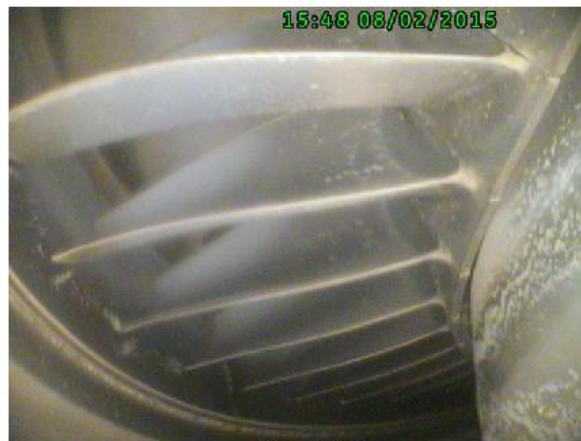
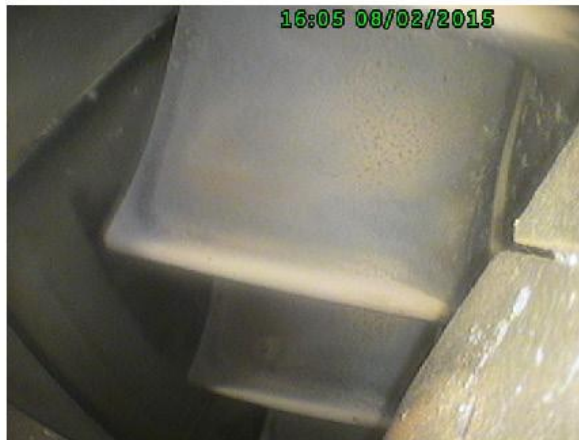
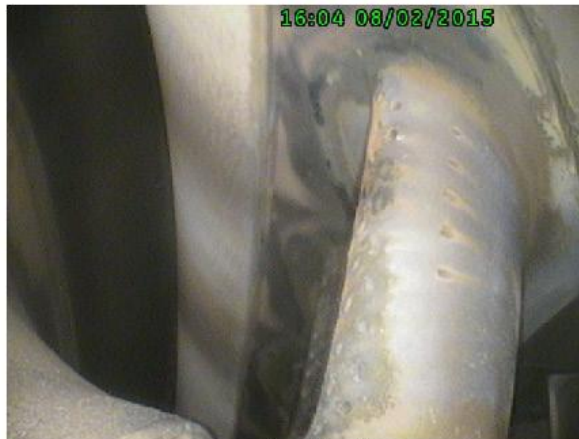
The turbine section components displayed no indications of any anomalies affecting normal operation, and all components observed showed normal running wear. All components showed water immersion damage. Please refer to photos No. 6 through 11.

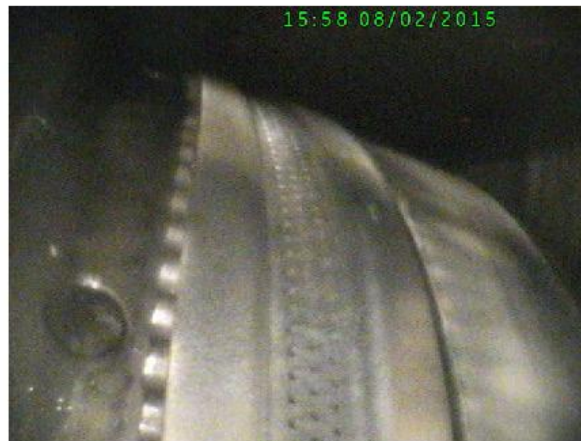
Photo No. 12  
Combustion chamber liner.

The combustion section components displayed no indications of any anomalies affecting normal operation, and all components observed showed normal running wear. All components showed water immersion damage. Please refer to photo No. 12.

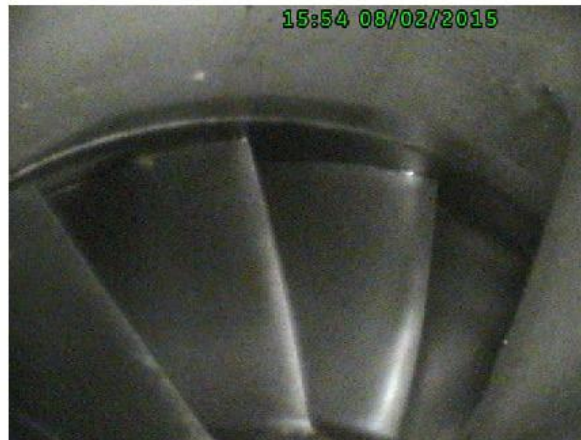
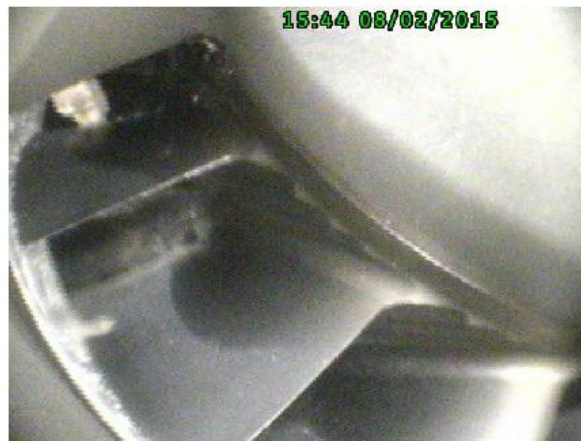
The compressor section components displayed no indications of any anomalies affecting normal operation, and all components observed showed normal running wear. All components showed water immersion damage. Please refer to photos No. 13 and 14.

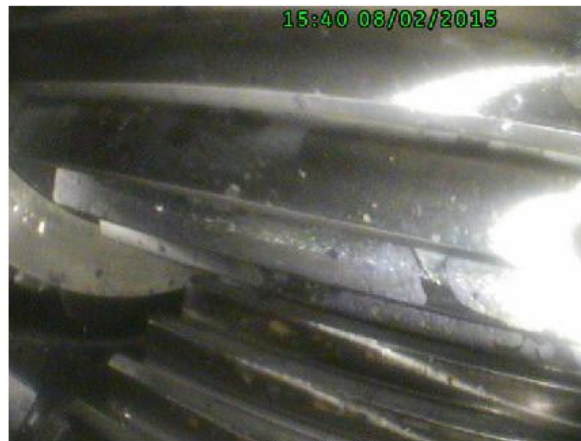
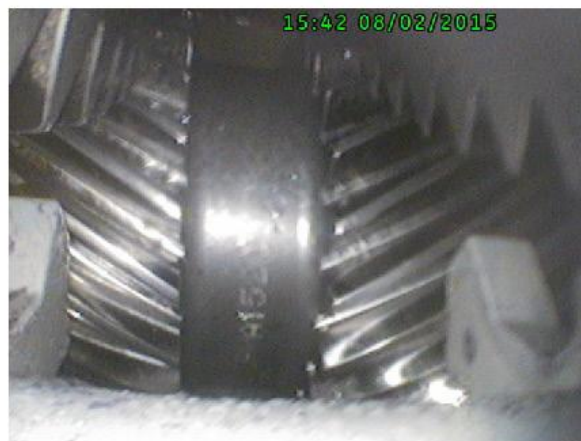
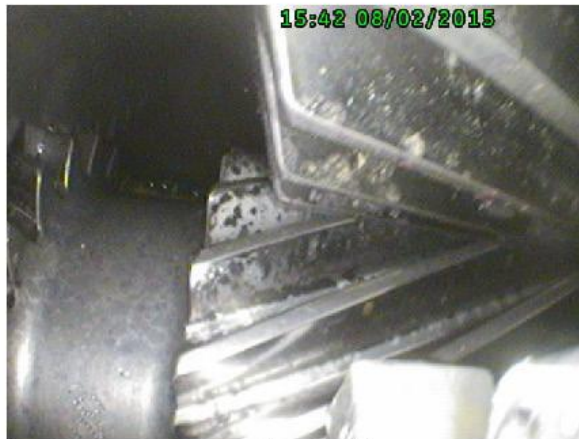
The reduction gearbox components displayed no indications of any anomalies affecting normal operation, and all components observed showed normal running wear. All components showed water immersion damage. Please refer to photos No. 15 through 17.

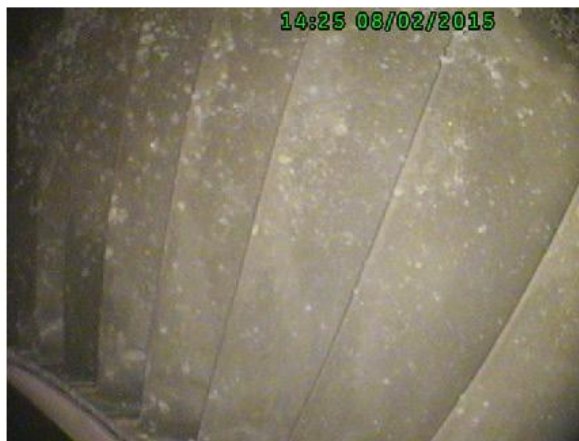
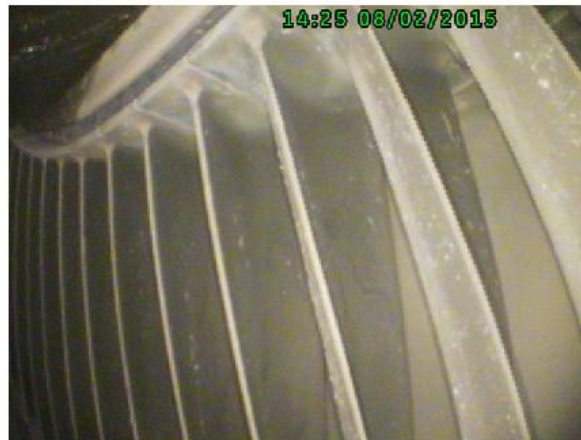
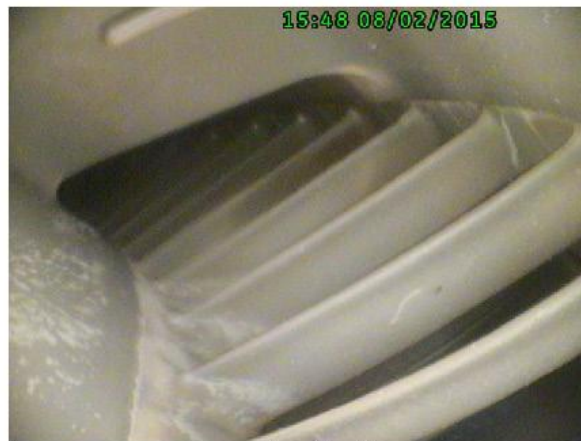
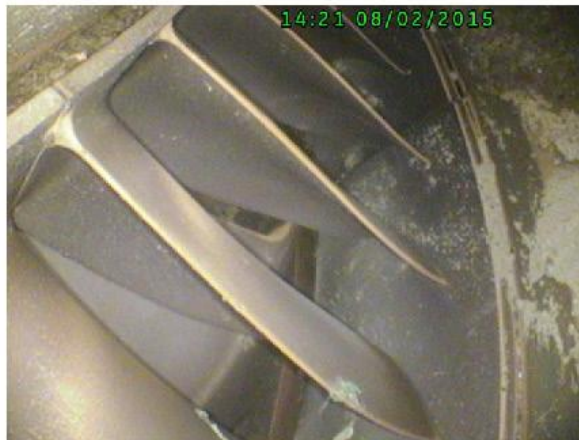
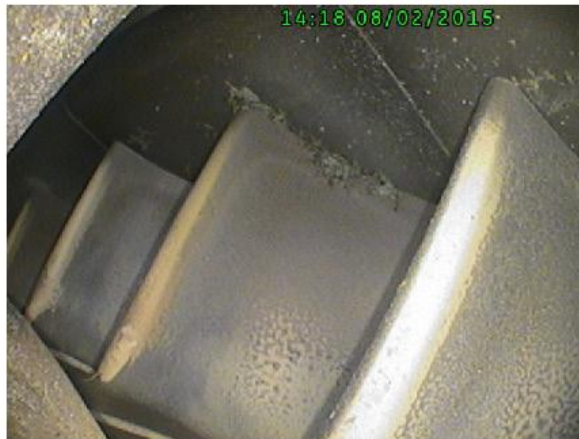
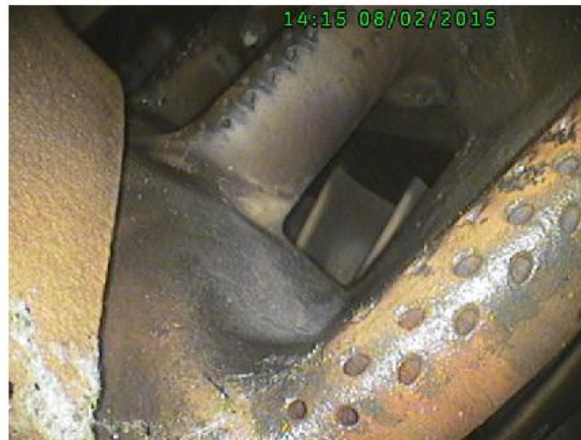
The turbine section components displayed no indications of any anomalies affecting normal operation, and all components observed showed normal running wear. All components showed water immersion damage. Please refer to photos No. 38 through 43.

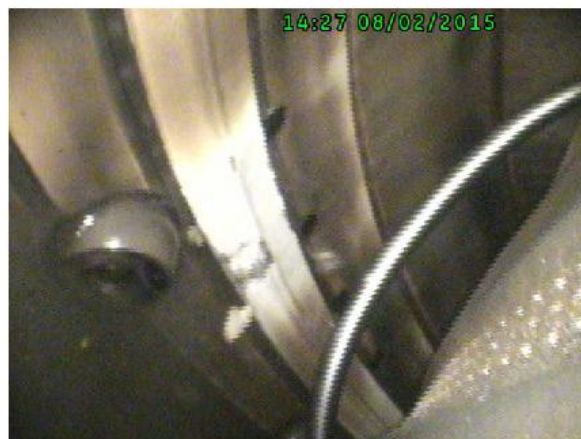
Photo No. 44  
Combustion chamber liner.

The combustion section components displayed no indications of any anomalies affecting normal operation, and all components observed showed normal running wear. All components showed water immersion damage. Please refer to photo No. 44.

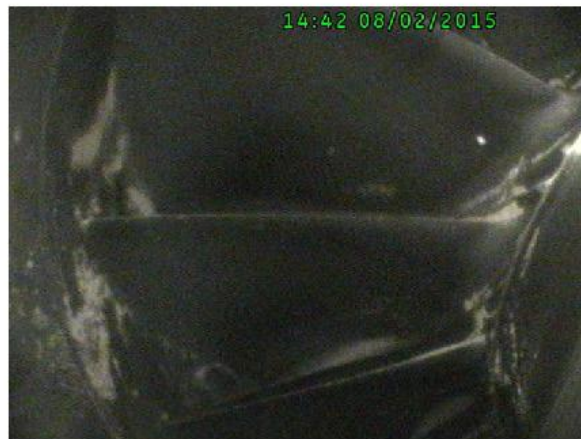
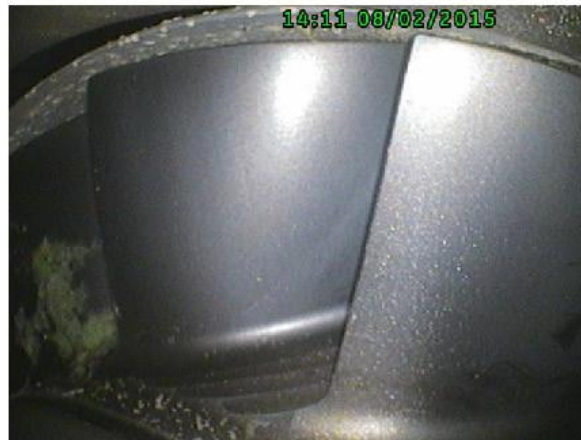
The compressor section components displayed no indications of any anomalies affecting normal operation, and all components observed showed normal running wear. All components showed water immersion damage. Please refer to photos No. 45 and 46.

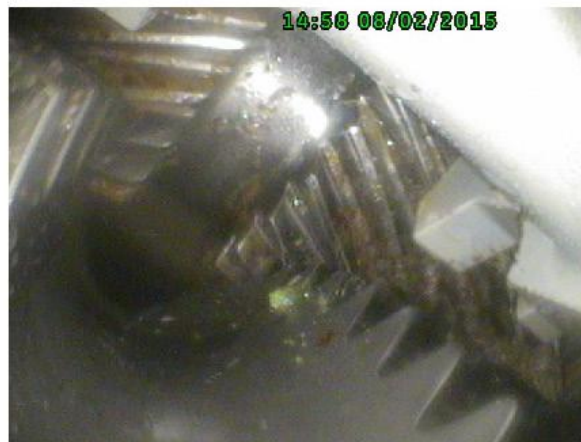
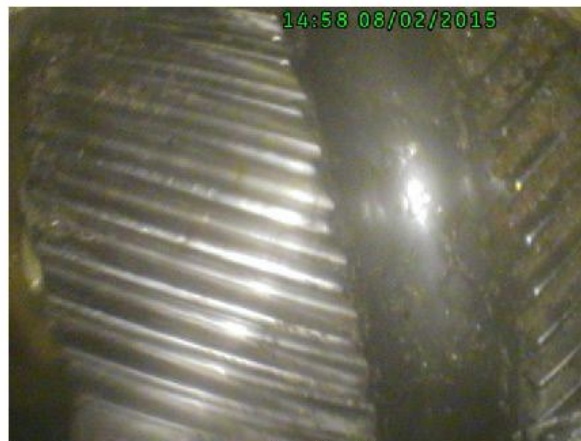
The reduction gearbox components displayed no indications of any anomalies affecting normal operation, and all components observed showed normal running wear. All components showed water immersion damage. Impact damage to the front inlet case prevented examination of the second stage spur gears. Please refer to photos No. 47 and 48.

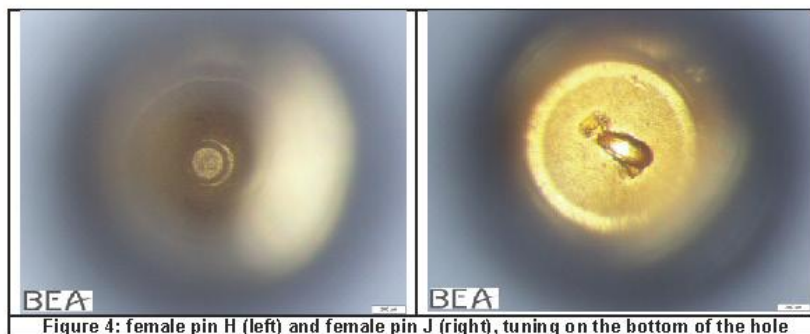
Figure 4: female pin H (left) and female pin J (right), tuning on the bottom of the hole

All these macroscopic views do not allow us to conclude.

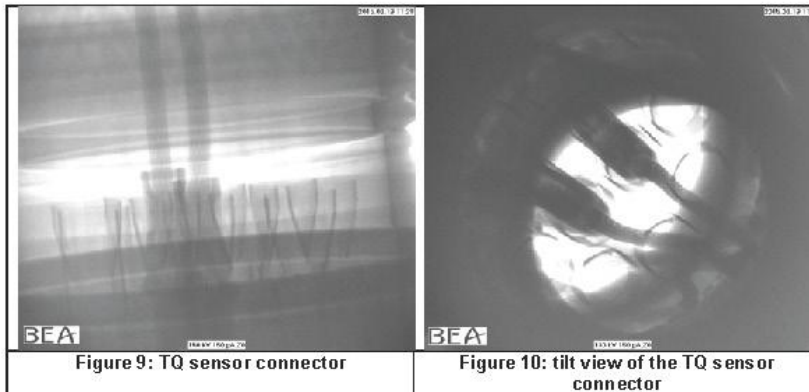
Only 2 female pins are connected to wires (pins 1 and 2). No trouble with these connections was detected by this examination. The other holes of the connector are empty.

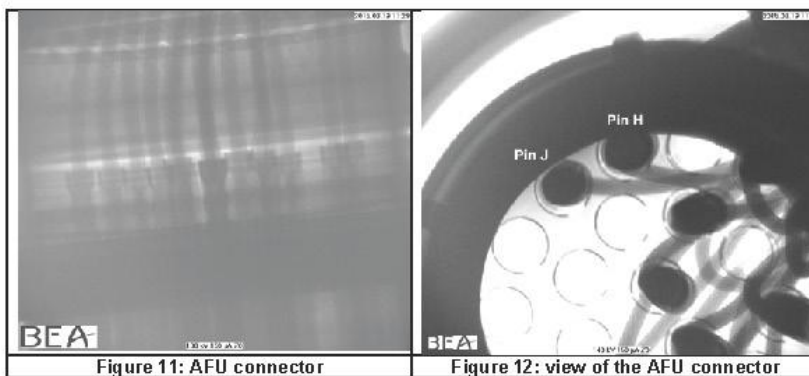
**AFU connector**

Inside the AFU connector, 15 female pins are connected to wires. Their references are: A-B-E-F-H-J-N-P-R-S-U-W-a-b-c. No trouble with these connections is detected by this examination.  
The other holes of the connector are empty (references: C-D-G-K-L-M-T-V-X-Y-Z).
