**Aviation Safety Council**

**GE235 Occurrence Investigation  
Factual Data Collection  
Group Report**

**Flight Recorders Group**

**July 2, 2015**

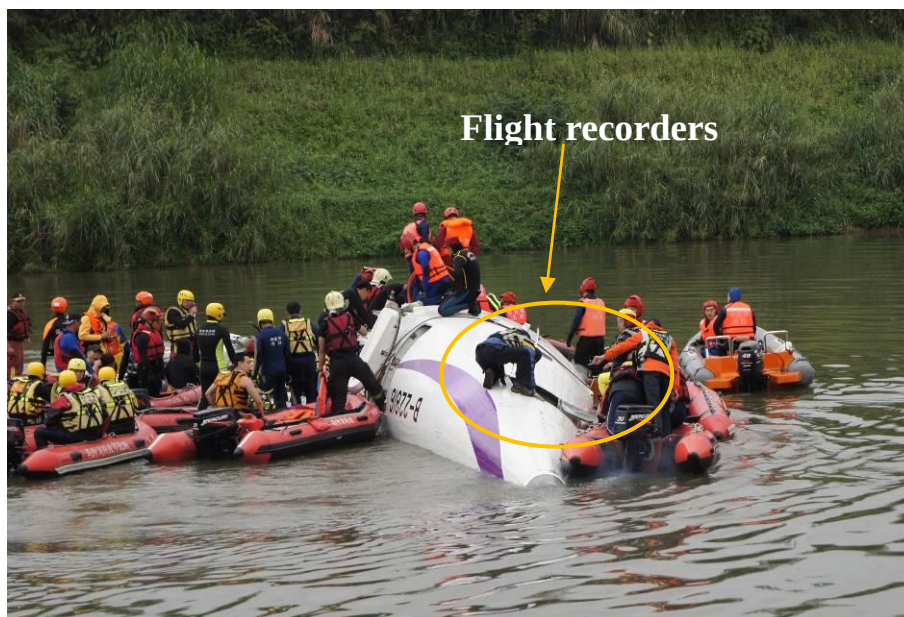
Both Cockpit Voice Recorder (CVR) and Flight Data Recorder (FDR) of the occurrence aircraft were recovered by ASC investigators in Keelung River (Figure 1.11-1) at 1605 hrs on Feb. 4th. Upon the first inspection by ASC investigators, it was found that there was no external damage on both recorders but immersed with water. The photo of CVR and FDR was shown in Figure 1.11-2.

Figure 1.11-1 Flight recorders were recovered by ASC investigators

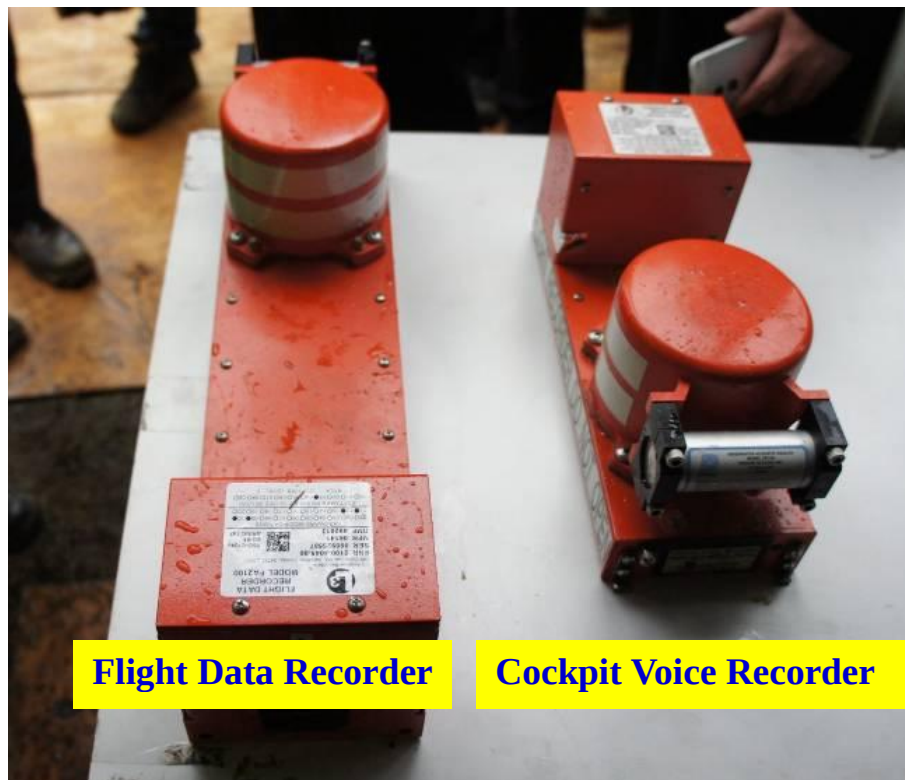
Figure 1.11-2 External view of Cockpit Voice Recorder and Flight Data Recorder

The CVR was recovered by ASC go-team at the tail section of main wreckage at 1605 hrs on Feb. 4th. Upon the first inspection by ASC investigators, it was evident that the CVR did not have any punctures, fire, or other penetration traces, and was found in good condition.

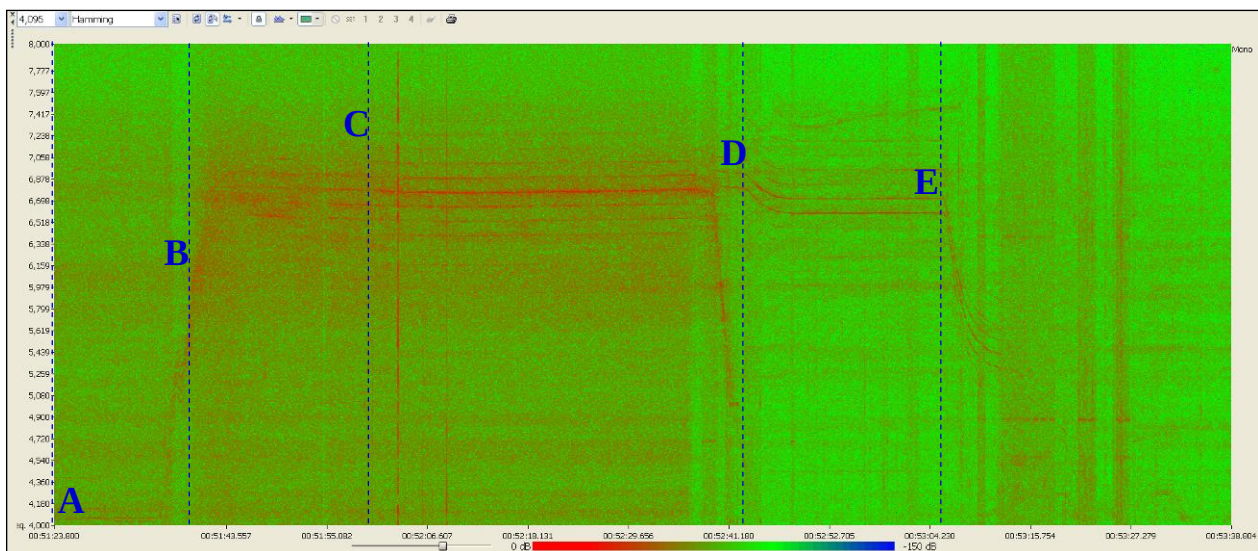
Figure 1.11-4 presents some selected CVR transcript and superposing with the relevant spectrogram that contains audio information from the CAM track between 1051:23.8 hrs and 1053:38.8 hrs. Both engines operated normally prior to 1052:39 hrs when the first sound of engine dropped off was heard. The trend matches the observation from FDR data that, engine no.2 propeller speed (denoted as NP) dropped immediately right after the autofeather of engine no.2. At 1052:43.0 hrs, Pilot Flying (denoted as PF) said that “*i will pull back engine one throttle*”; and at 1053:06.4, PF said that “*pull back number one*”, FDR data indicated that no.1 engine NP dropped off immediately.

Figure1.11-4 GE235 Spectrogram of the CAM recording

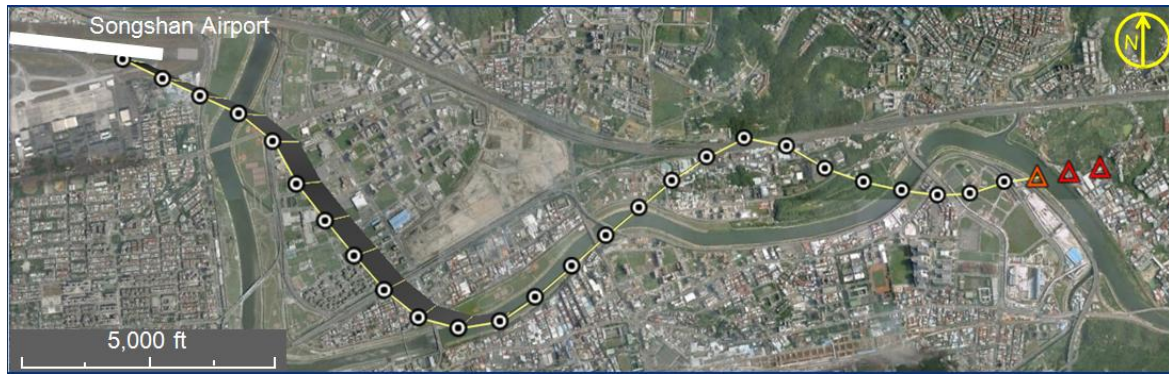
Figure 1.11-6 shows GE235 radar track superposing with satellite image. There are three red triangular marks, which were predicted positions from radar system and they were invalid for future analysis. The original radar data indicated that the last valid data occurred at local time 1054:35.26 hrs, slant range between the aircraft to the runway 28 threshold of Songshan airport was 2.84NM and bearing angle was 98.1 degrees.

Figure 1.11-6 GE235 radar track

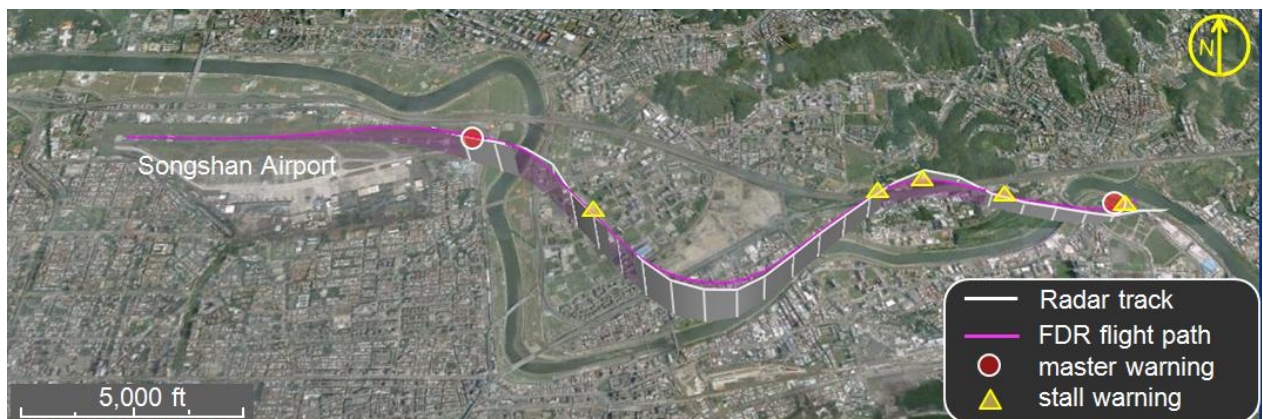
The flight path is determined by three recording parameters- GPS latitude, GPS longitude, and baro-corrected altitude, with sampling rate 1 Hz. At 1054:35 hrs, the last recorded position was N25°03'46.576", E121°37'1.291". Based on the CVR and FDR factual information, the sequence of events of GE235 is listed in Table 1.11-10. Figure 1.11-8 shows GE235 flight path and radar track, superposing with an aerial photo. Figure 1.11-9 also indicates ten place marks during 1053:07.7 hrs and 1053:59.7 hrs. Figure 1.11-10 presents GE235 flight path, satellite image and eight place marks during the last 23 seconds.

Figure 1.11-8 Superposing of GE235 flight path, radar track and warnings

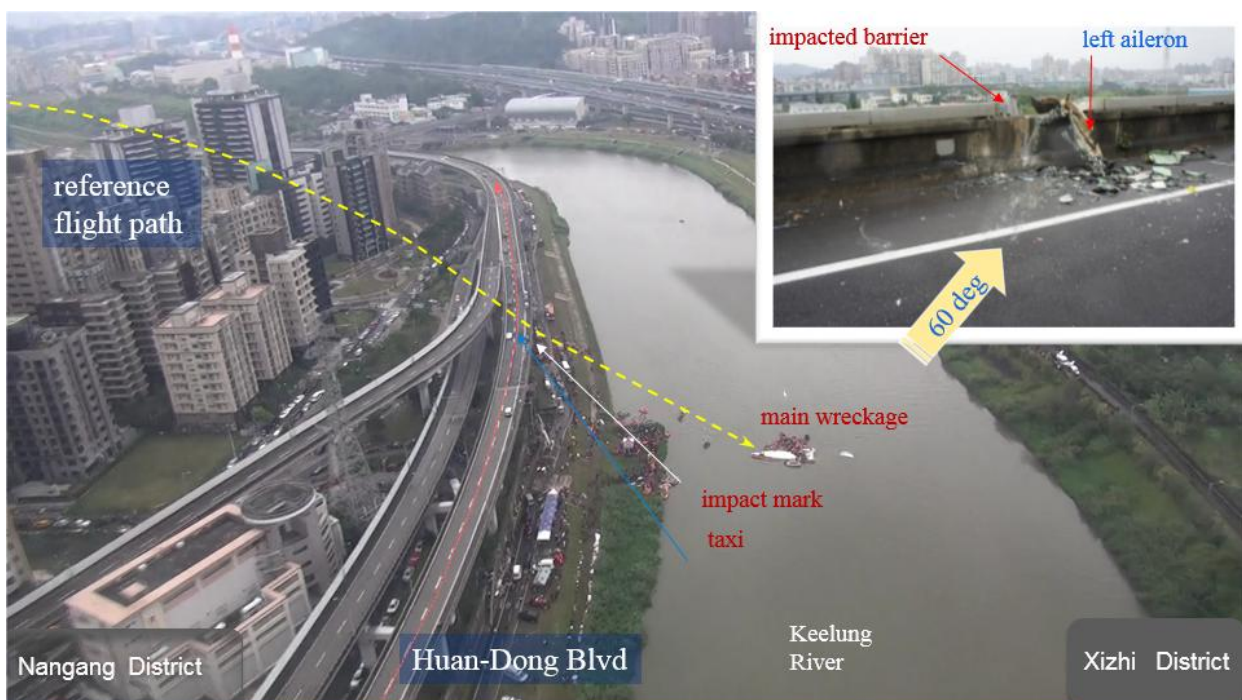
The impact mark made by GE235 indicated the aircraft impacted the Huan-Dong Blvd viaduct before crashing into Keelung River. Refer to Figure 1.12-1, there are several high buildings in the southern area of the Huan-Dong Blvd. Keelung River is at the north side of the Huan-Dong Blvd, and the water depth of the river is between one to two meters.

Figure 1.12-1 Aerial Photo of GE235 crash site

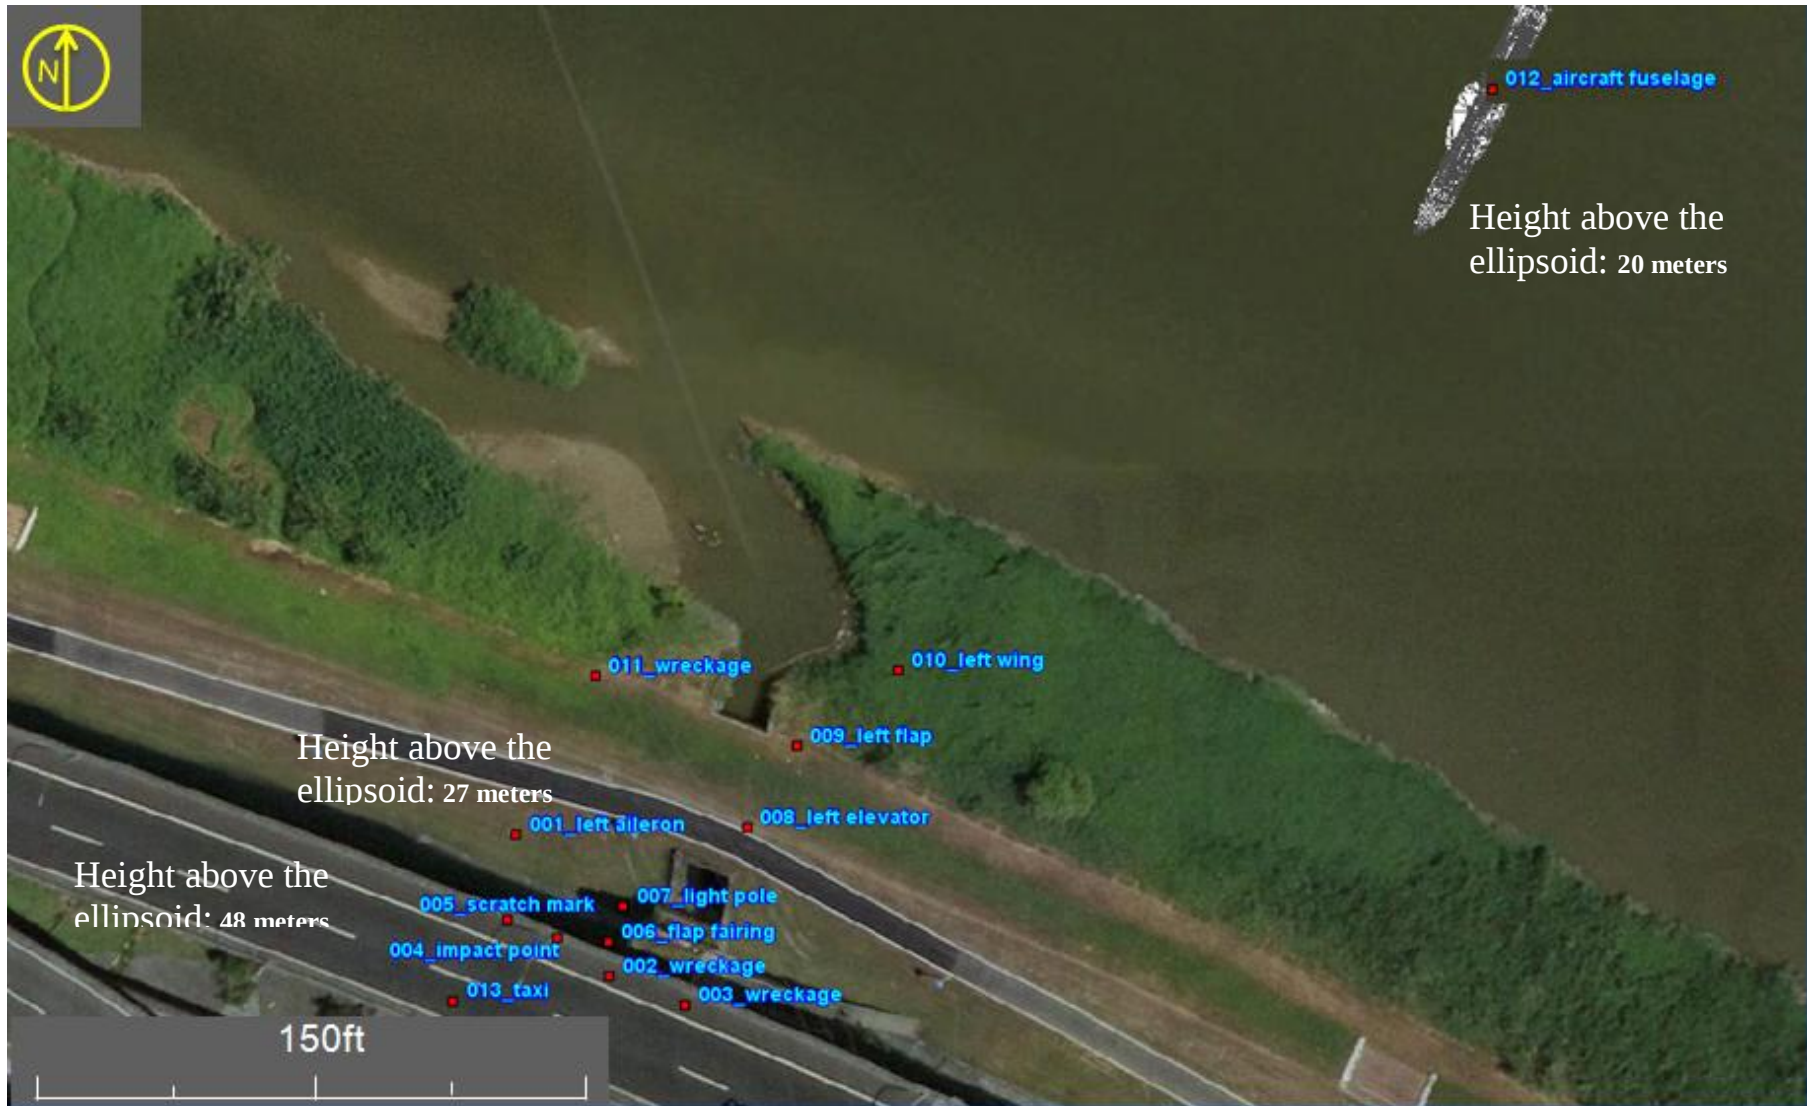
Main wreckage was nearly upside down in the middle of the Keelung River, and the reference heading was about 25 degrees. The reference position was N25°3'48.54, E 121°37'3.13", the height above the ellipsoid was 20 meters, and the water depth was about one to two meters.

Figure 1.12-2 Site survey data superposing with an aerial photo

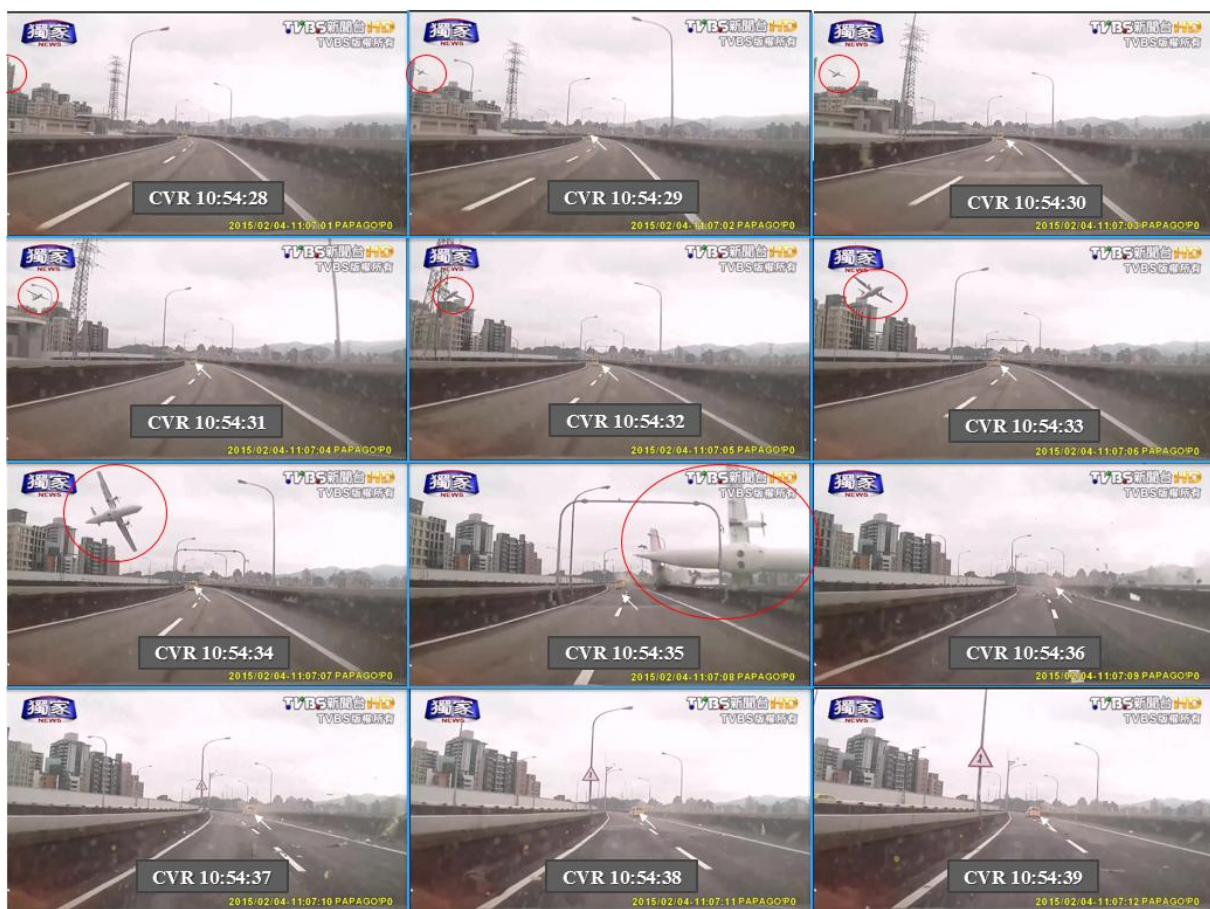
After the occurrence, ASC investigators collected traffic surveillance video at Huan-Dong Blvd and several dashcam videos from nearby vehicles. Several videos showed that the aircraft hit a taxi, impacted the viaduct, and then crashed into Keelung River. All videos were examined during the investigation. When the occurrence happened, two ground vehicles (noted as black color and silver color) were traveling westbound on Huan-Dong Blvd. Their dashcam videos contained clear images and were helpful for the investigation. To correlate the time of video and flight recorders, the unidentified sound (1054:34.8 hrs) of CVR before aircraft crash was used to be the common event of the aircraft hitting the taxi and viaduct on the video. Relevant video snapshots of the silver car dashcam with CVR time are shown in Figure 1.12-8, the copyright of video was authorized by TVBS for public publication.

Figure 1.12-8 Dashcam video snapshots extracted from the silver car (authorized by TVBS)

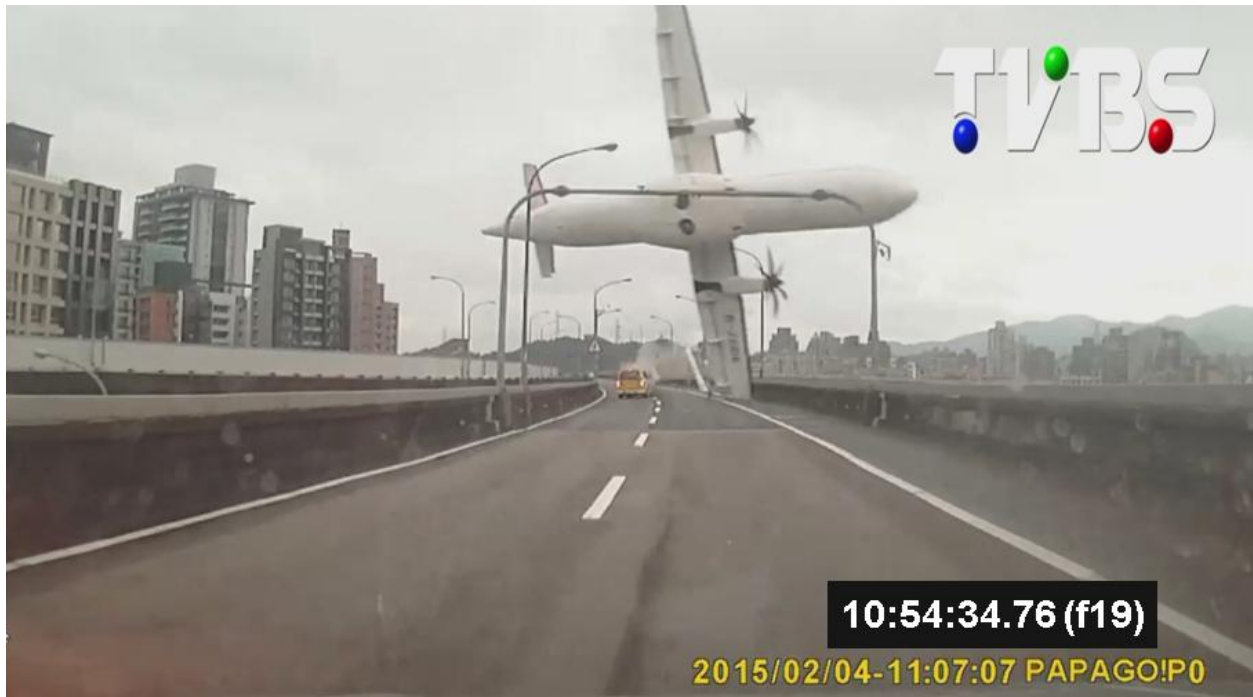
meaning that a frame equals to 0.04 second. Based on the dashcam video and the site survey data, the aircraft banked to left at about 90 degrees and the distance between the taxi and the barrier was about 9 meters. The aircraft flew 9 meters in 5 frames (0.2 seconds), shown in Figure 1.12-9 to Figure 1.12-11. Figure 1.12-11 showed that the aircraft impacted the north barrier of Huan-Dong Blvd, represented by the 19th frame of the video timing at 1107:07 hrs, which can be correlated to CVR time as 1054:34.76 hrs.

Figure 1.12-11 The 19<sup>th</sup> frame of dashcam videos of silver car (CVR 1054:34.76 hrs)

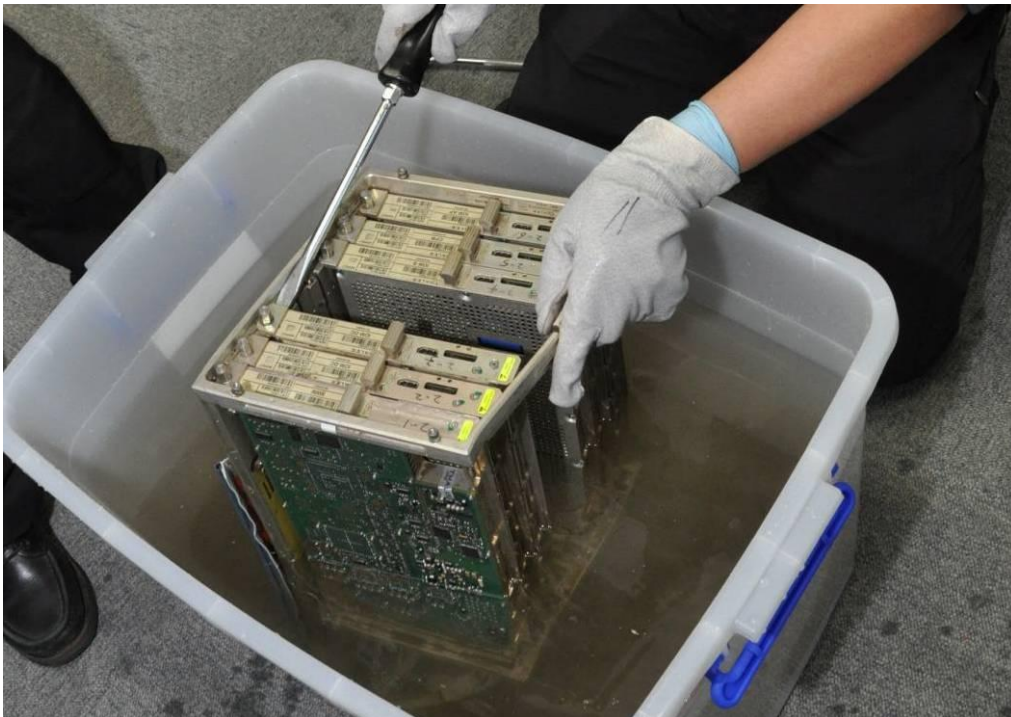
Because of the cockpit instrument panel was seriously deformed, investigators used electrical tools, such as grinder and drill, to remove these DUs. The external case of both MFC were slightly deformed. All PCBs were cleaned with water and removed from MFC before shipping to BEA, photo shown as Figure 1.16-1. Each device was tagged and photo documented into the wreckage database. Those devices were then packaged into water proof hard cases for shipping to BEA or TSB.

Figure 1.16-1 PCBs teardown from CAC rack
