## National Transportation Safety Board Aviation Accident Preliminary Report

| <b>Location:</b> | Fullerton, CA | <b>Accident Number:</b> | WPR19FA115 |
| <b>Date &amp; Time:</b> | 04/18/2019, 1953 PDT | <b>Registration:</b> | N65MY |
| <b>Aircraft:</b> | Beech 60 | <b>Injuries:</b> | 1 Fatal |

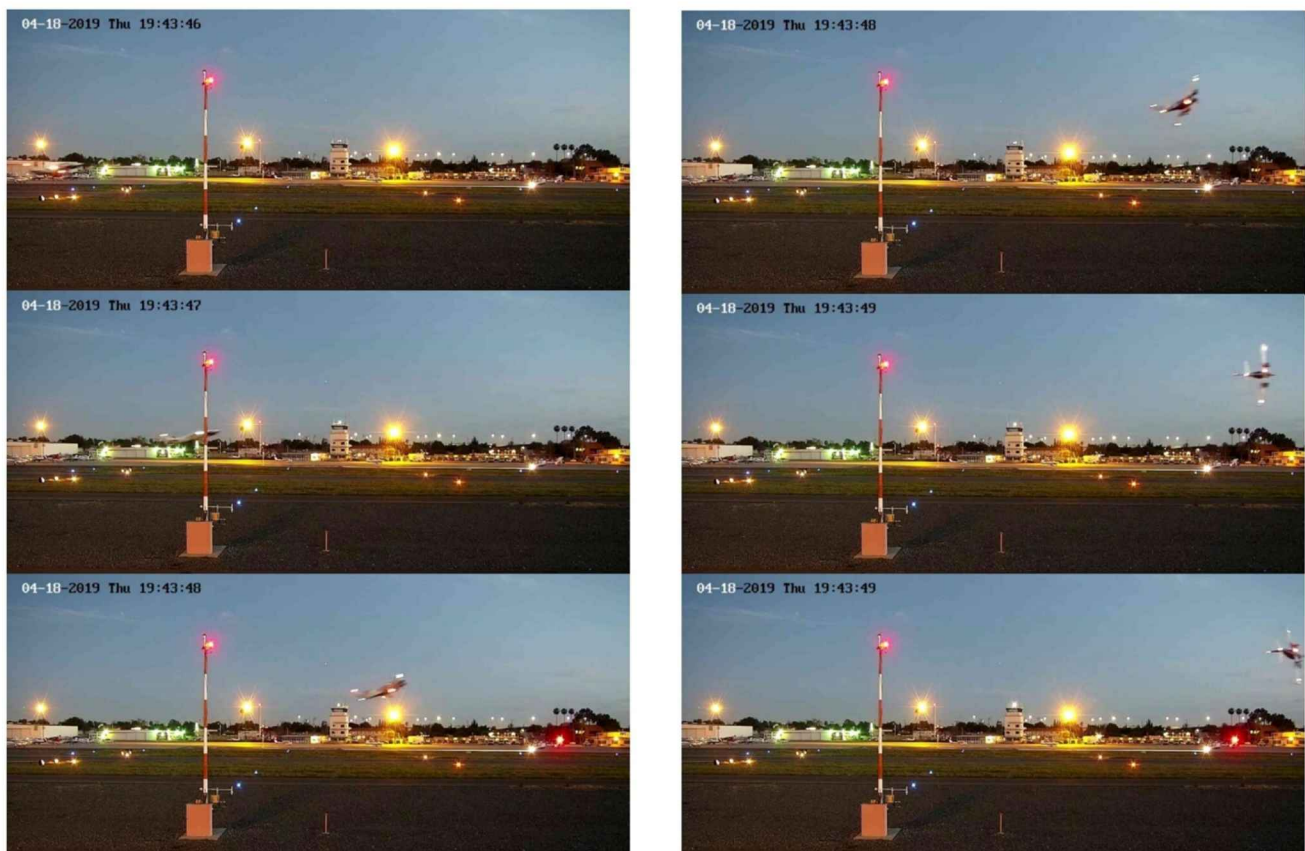
The accident sequence was captured by a series of surveillance video cameras located at multiple vantage points within the airport. Preliminary review of the video data revealed that the pilot boarded the airplane at his hangar at 1930. He started the engines, and taxied to the runway 24 runup where the airplane remained for the next 11 1/2 minutes. During that time, he was provided his IFR clearance by the tower controller. The airplane then taxied to the hold short line on taxiway A at the approach end of runway 24, and after the pilot was given the takeoff clearance, the airplane began the takeoff roll. The airplane was airborne after traveling about 1,300 ft down the runway, and about 2 seconds after rotation it began to roll to the left. Three seconds later, the airplane had reached an altitude of about 80 ft above ground level (agl), and was in a 90° left bank. The nose then dropped as the airplane rolled inverted, and struck taxiway E in a right-wing-low, nose down attitude. (See Figure 1).

Figure 1 – Accident Sequence Viewed Midfield to the South (timestamp inaccurate)
