**Aviation Safety Council  
Taipei, Taiwan**

**GE235 Occurrence Investigation  
Factual Data Collection  
Group Report**

**Airworthiness Group**

**ASC-FRP-15-07-003**

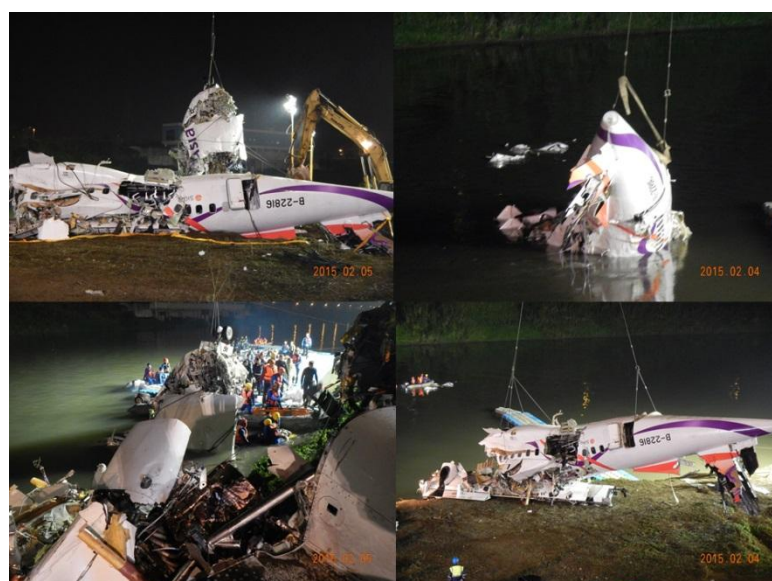
Figure 1.12-1 Wreckage recovery operations

The aircraft wreckage was broken into the cockpit and middle/aft fuselage two major portions with its nose immersed in the mud of riverbed. A floating bridge and three heavy lift vehicles were deployed by the Army Engineering Corps to facilitate the rescue of the victims and recovery of the aircraft wreckage. While the search and rescue operations were continuously going, the salvage operation of aircraft wreckage was commenced in the late afternoon of the occurrence day. The FDR and CVR of the aircraft were found at 1605 local time and had been delivered to ASC. Figure 1.12-1 showed that those two major portions of the wreckage were lifting up and moved to offshore ground of the river. By the late afternoon of day two salvage operation, the aforementioned two major portions and both engines were all successfully recovered.

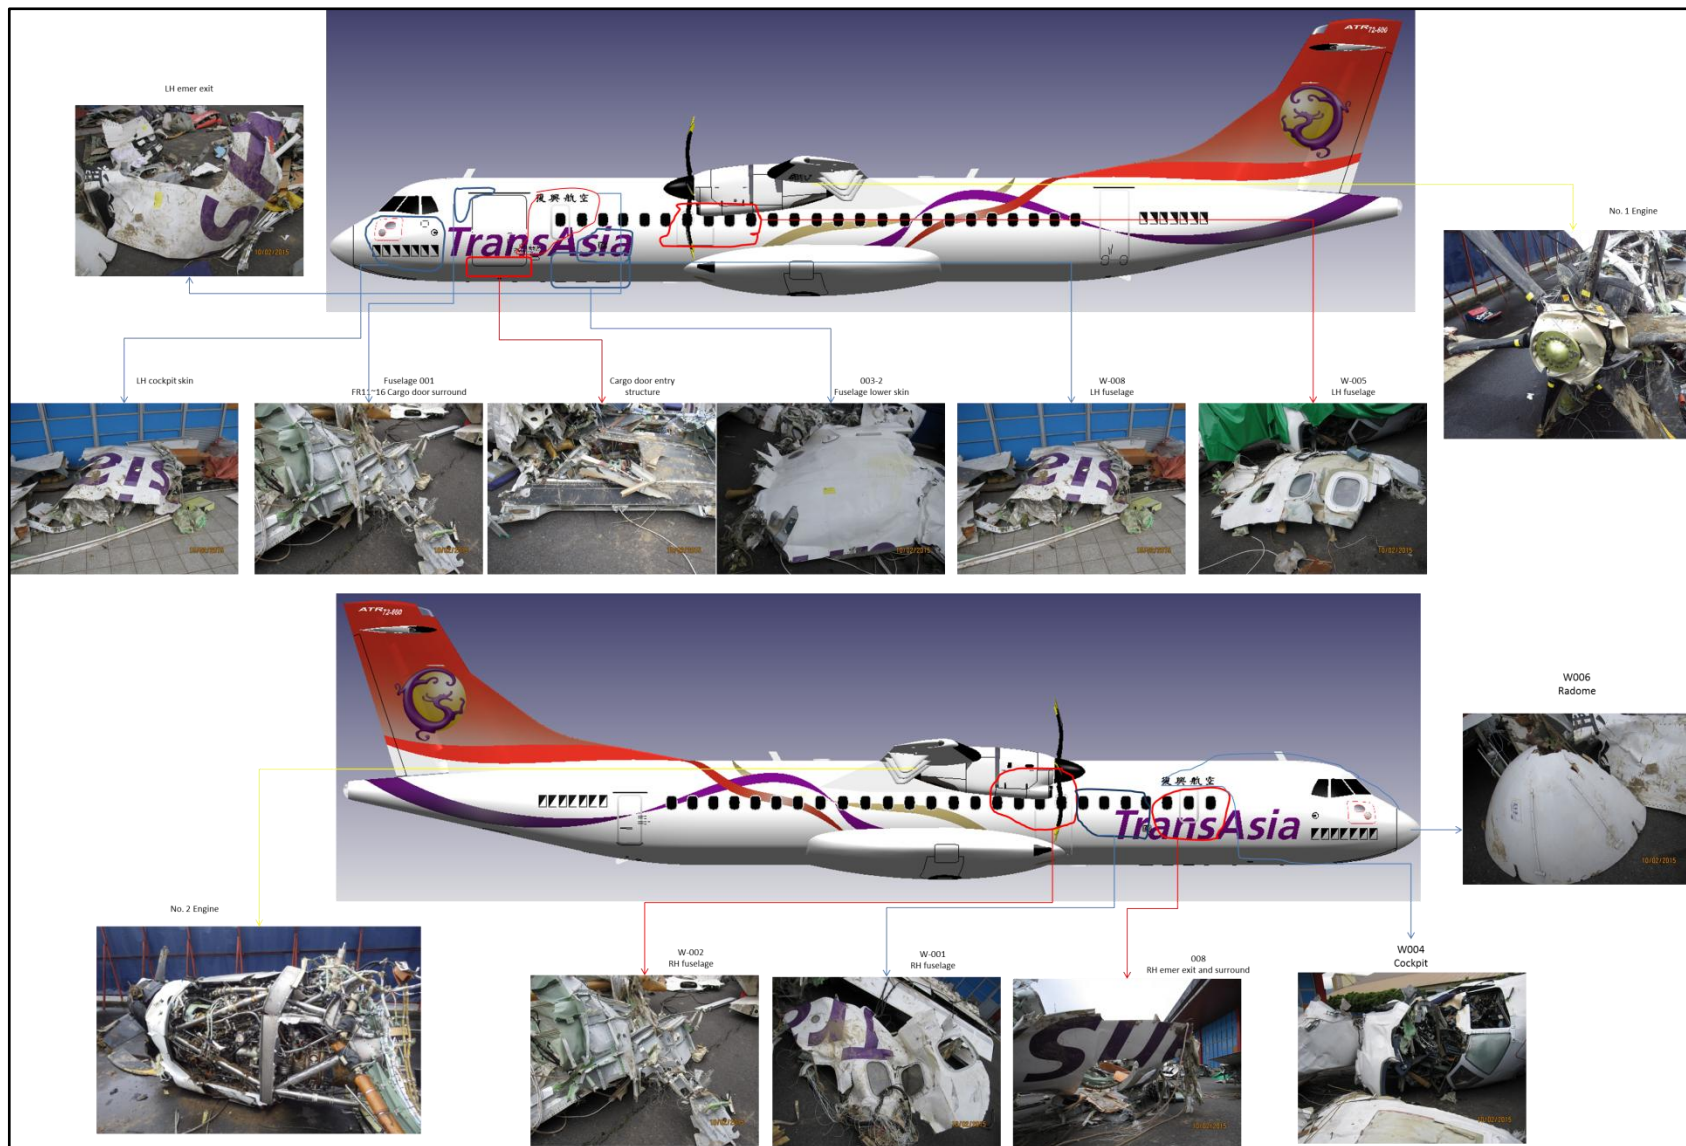
Figure 1.12-3 Recovered aircraft wreckage (2)

Figure 1.12-2 and 1.12-3 show the mappings of recovered aircraft wreckage during salvage operations. Total wreckage recovered is approximately 85% of the whole aircraft. The remaining unrecovered 15% of the whole wreckage is mainly between the after cargo area and forward of the ice shield area as shown in Figure 1.12-2. Larger pieces of aircraft wreckage are listed as follows.

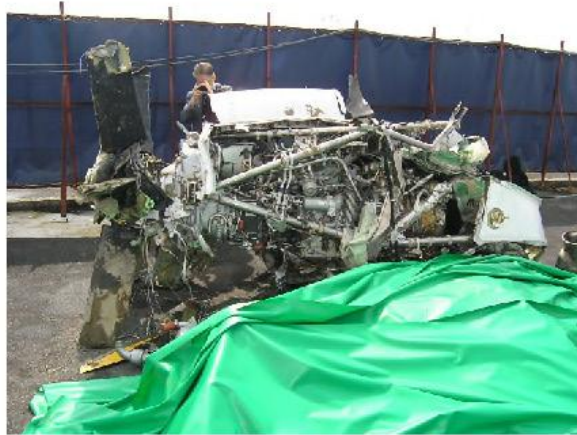
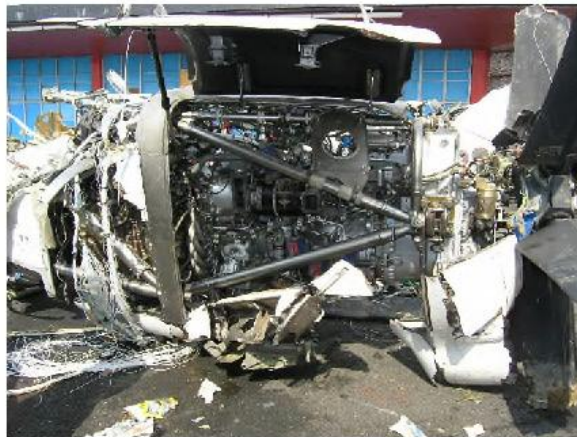
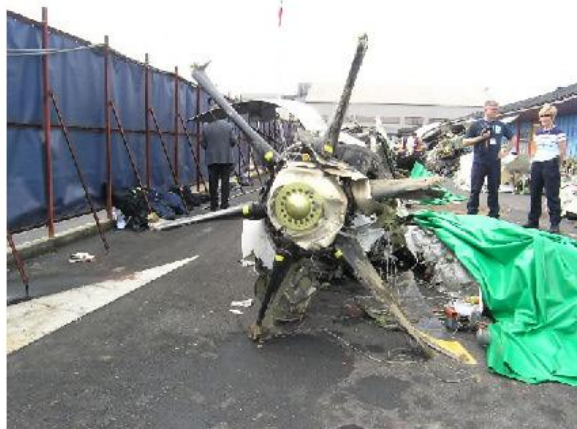
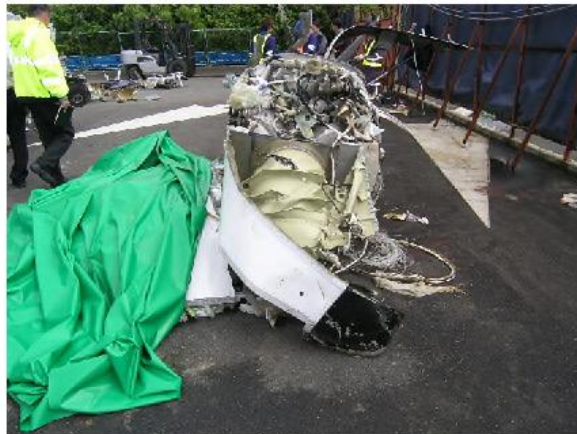
Photo No. 1  
Engine left hand view.

Photo No. 2  
Engine right hand view.

Photo No. 3  
Engine forward view.

Photo No. 4  
Engine rear view.

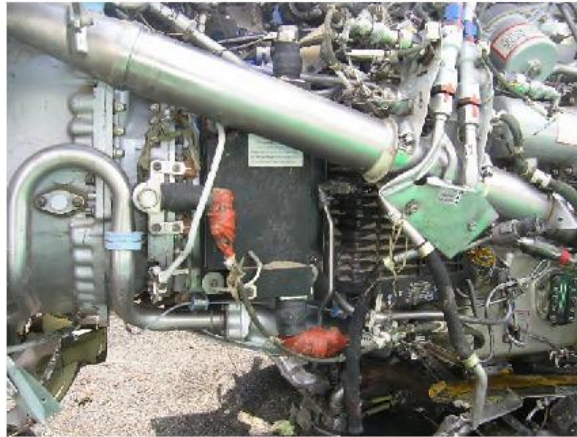
Photo No. 5

Compressor inlet case, autofeather unit and engine electronic control, in-situ.

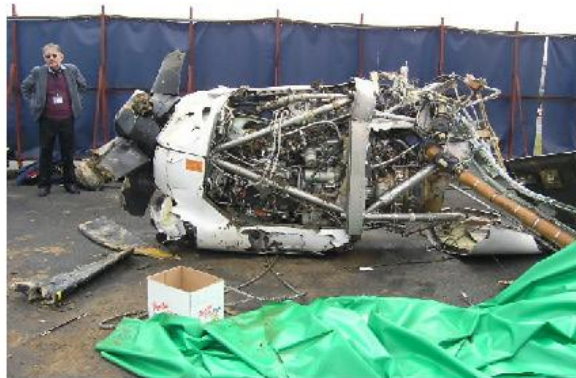
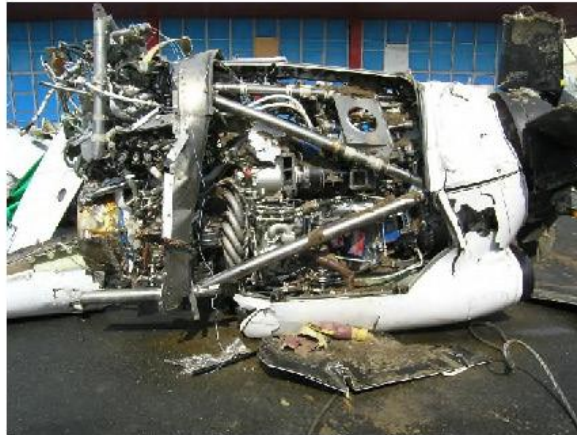
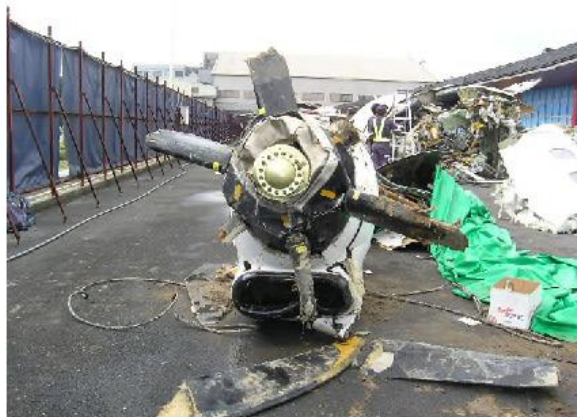
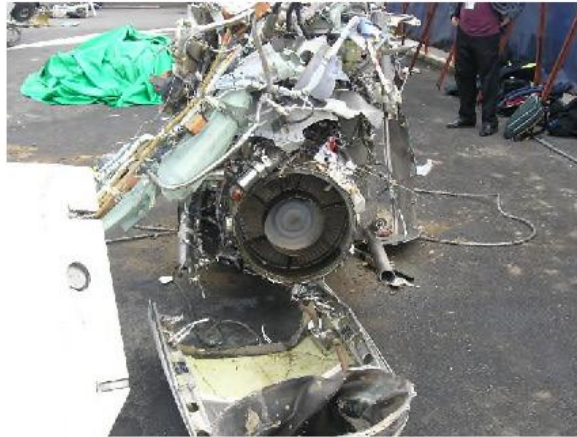
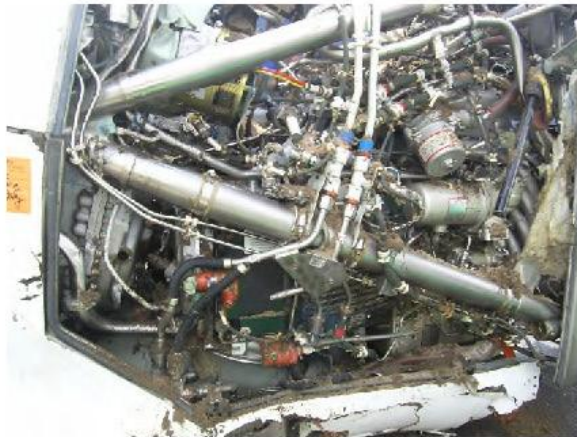
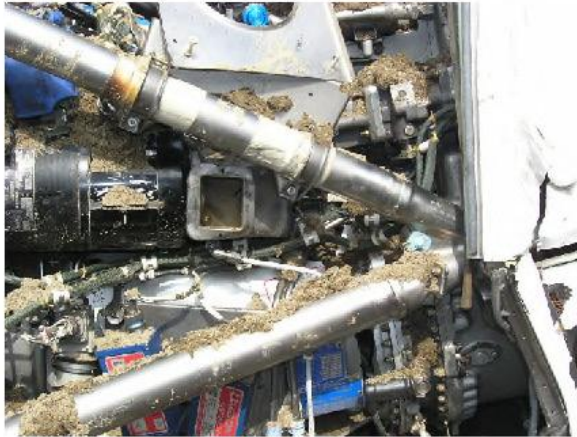
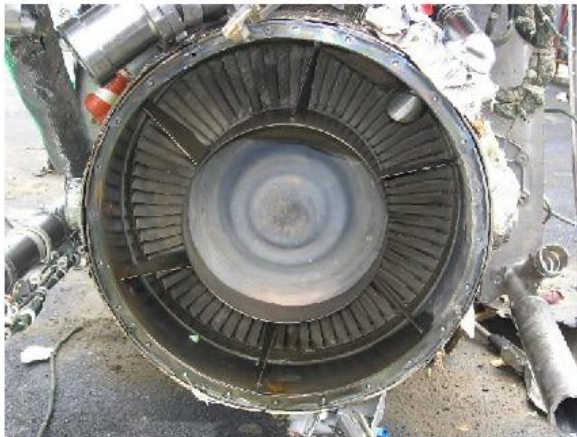
Photo No. 31  
Engine left hand view.

Photo No. 32  
Engine right hand view.

Photo No. 33  
Engine forward view.

Photo No. 34  
Engine rear view.

Photo No. 35  
Compressor inlet case, Autofeather unit and engine electronic control, in-situ.

Photo No. 36  
Compressor inlet case, right hand side.

Photo No. 37  
Exhaust duct and power turbines.

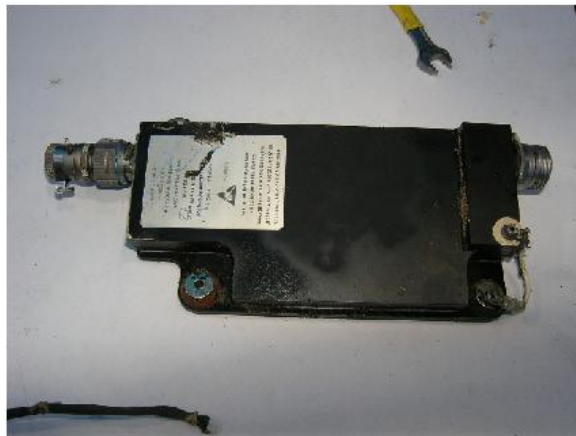
Photo No. 53  
Autofeather unit.

**Autofeather Unit:** Rosemont P/N 30048-0000-28 Rev D, P&WC P/N 3078166-01 S/N RT2362. The lower canon plug boss was deformed by impact. The unit was re-immersed in fresh water and packed sealed in water for shipping. Please refer to photos No. 53 through 55.

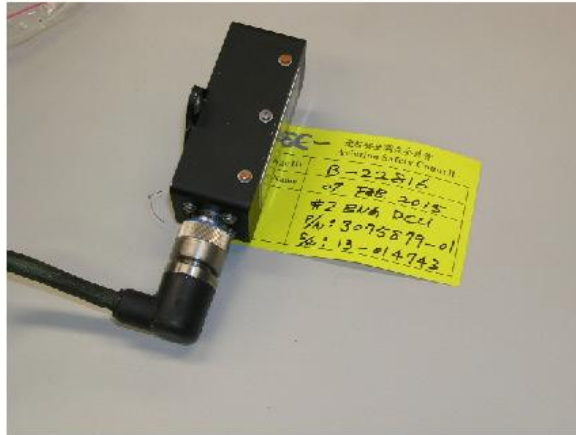
Photo No. 56  
Data collection unit.

**Data Collection Unit:** Safran P/N 62133, P&WC P/N 3075879-0, S/N 13014743. Please refer to photos No. 24 and 25.

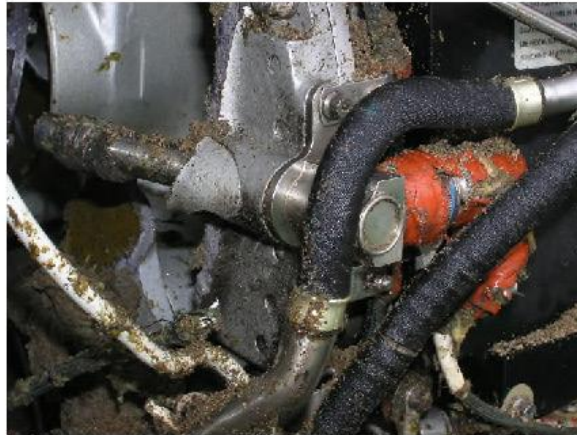
**Front Inlet Case:** The front inlet case was crushed and the reduction gearbox was forced aft and upward into the engine mount structure. The torque sensor No. 1 probe was deformed due to impact fracture of the inlet housing mounting boss. The autofeather unit lower canon plug boss was deformed by impact. The rest of the front inlet case mounted controls and accessories were in place and intact.

**Torque Sensor No. 1:** P/N 3073471-01, S/N CH1468. Please refer to photo No. 58 and 59.

Photo No. 58  
Torque sensor No. 1, in situ.

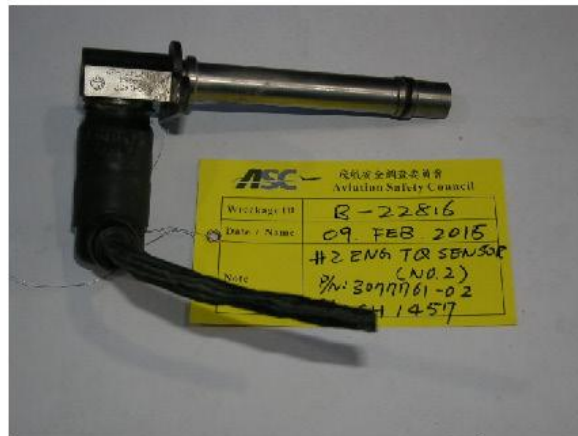
Photo No. 59  
Torque sensor No. 2.

**Torque Sensor No. 2:** P/N 3073471-02, S/N CH1457. Please refer to photo No. 59.

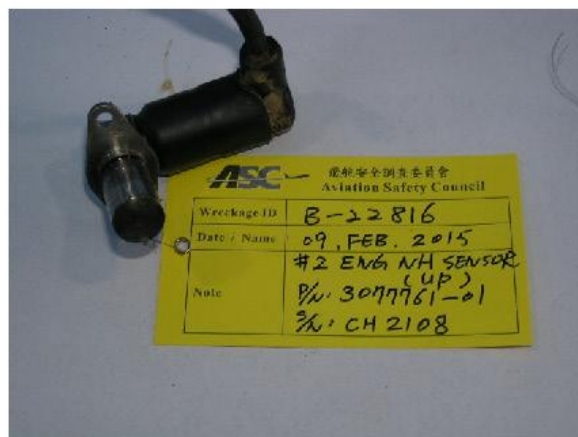
Photo No. 60  
Nh sensor upper.

Nh Sensor (upper): P/N 3077761-01, S/N CH2108. Please refer to photo No. 60.

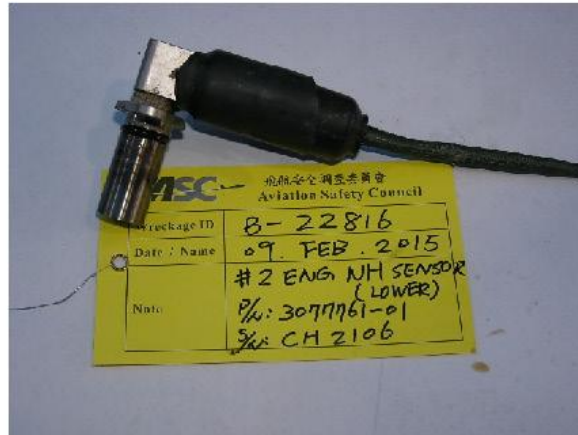
Photo No. 61  
Nh sensor lower.

Nh Sensor (lower): P/N 3077761-01, S/N CH2106. Please refer to photo No. 61.

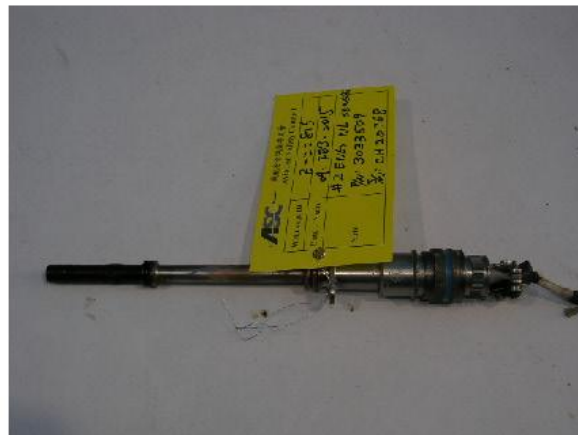
Photo No. 62  
NI sensor.

**NI Sensor:** P/N 3033509, S/N CH20768. Please refer to photo No. 62.

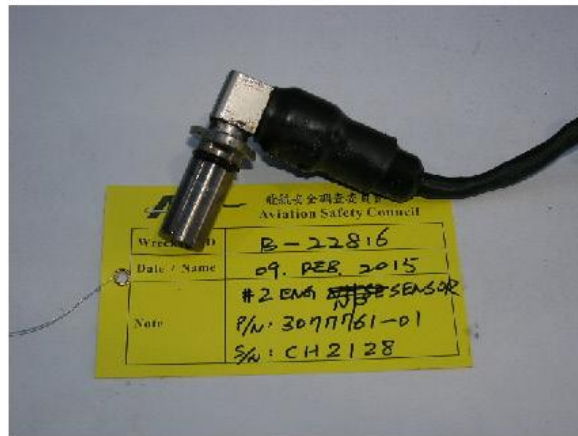
Photo No. 63  
Np sensor

**NP Sensor:** P/N3077761-01, S/N CH2128. Please refer to photo No. 63.

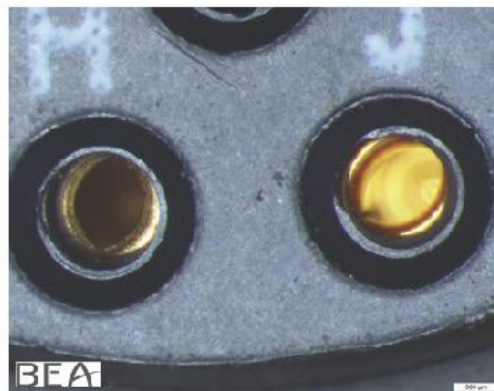
Figure 3: Pin H and J

The macroscopic examination showed a difference between the pin H of AFU connector on cable 2 and the other pins on this connector.

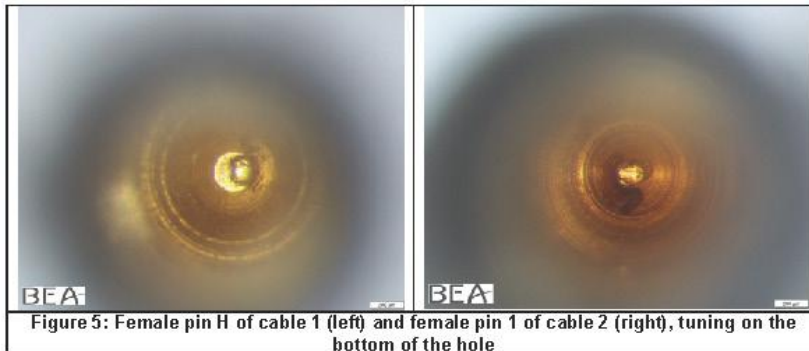
Pictures of the female pin H of cable 1 and the female pin 1 of TQ sensor (cable 2) were taken.

All these macroscopic views do not allow us to conclude.

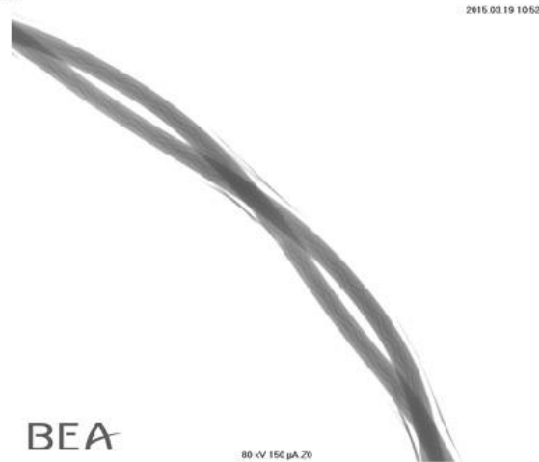
**Figure 6: typical RX picture of the cable between the 2 connectors**

Both cables RX examination provide the same result. No defect was detected on these cables.
