**Aviation Safety Council**

**GE235 Occurrence Investigation  
Factual Data Collection  
Group Report**

**Flight Recorders Group**

**July 2, 2015**

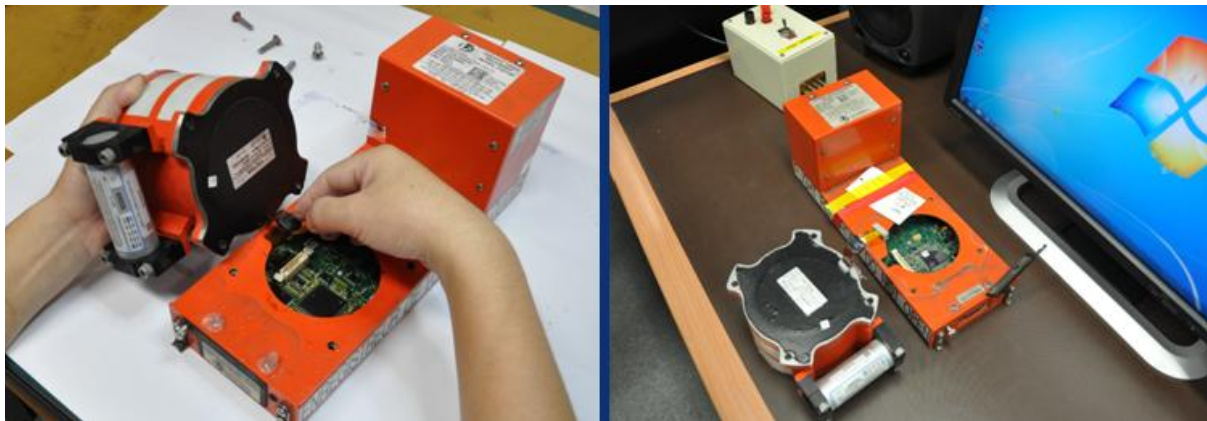
Figure 1.11-3 Connecting the CSMU of GE235 SSCVR to chassis

The CVR was recovered by ASC go-team at the tail section of main wreckage at 1605 hrs on Feb. 4th. Upon the first inspection by ASC investigators, it was evident that the CVR did not have any punctures, fire, or other penetration traces, and was found in good condition.

After cleaning and drying process, ASC investigators utilized the L-3 Accident Investigation Kits (AIK) to download voice data according to L-3 FA2100 manual and ASC's download procedures, shown in Figure 1.11-3. The CVR data was downloaded, and contained 124 minutes 14.4 seconds of 4 channel audio data. The audio quality of each channel is either good or excellent, and the quality level are shown in the Table 1.11-1. Detailed definition of SSCVR audio quality is available in Appendix 1:

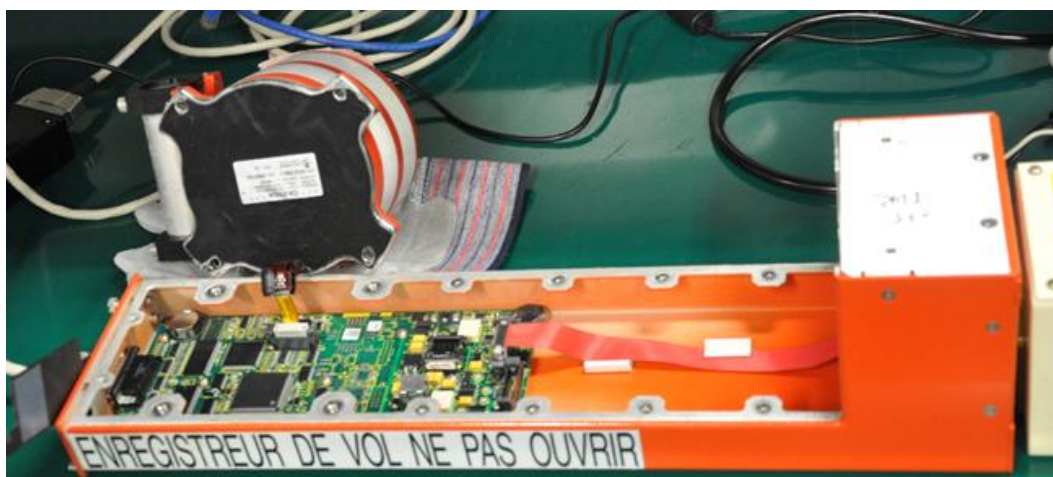
Figure1.11-5 Connecting the CSMU of GE235 FDR to chassis

The FDR was recovered by ASC Go-team at the tail section of main wreckage at 1605 hrs on Feb. 4th. Upon the first inspection by ASC investigators, it was evident that the FDR did not have any punctures, fire, or other penetration traces, and was found in good condition. After cleaning and drying the CSMU and chassis, ASC investigators used normal procedure to download FDR raw data, shown as in Figure 1.11-5.

The FDR recording contained 67 hours 22 minutes and 56 seconds of data. The occurrence flight was the last flight of the recording and its duration was 13 minutes and 18 seconds. According to ATR readout document<sup>2</sup>, FDR raw data was converted into engineering units and total number of the recording parameters were about 750. All the recorded parameters are listed in Appendix 3. Data plots for the entire occurrence flight are included in Appendix 4.

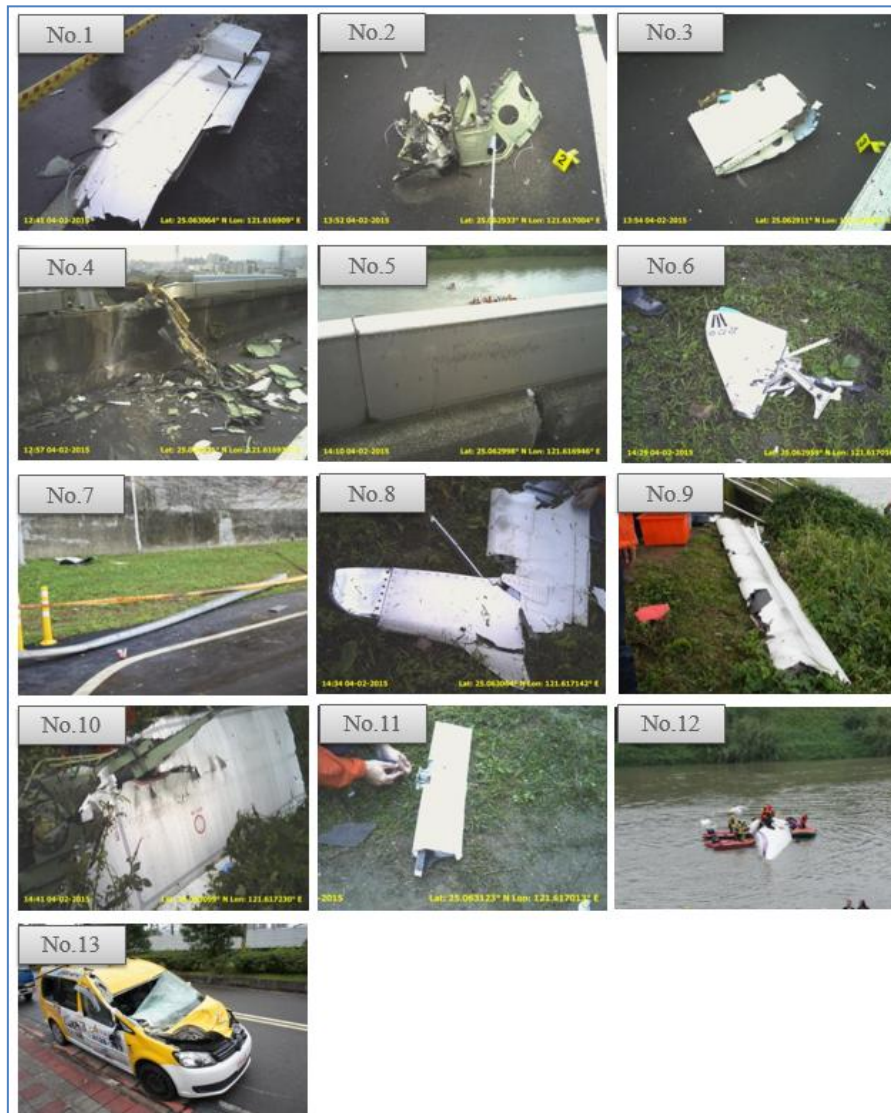
Figure 1.12-3 Site survey- wreckage identification numbers and photos.

The site survey was conducted by ASC investigators with a Trimble GEO XH GPS receiver and a Leica D510 laser ranger on the date of occurrence. When Go-team arrived at the occurrence site, IIC requested 3 investigators went to the Huan-Dong Blvd to find the first impact point. There were some small debris left on the Huan-Dong Blvd, and one light pole on the Huan-Dong Blvd was broken, and fell down to the river side. There were several debris of control surfaces located at the river side. The aircraft fuselage and the flight deck were in the middle of the

The height above ground level of the Huan-Dong Blvd was about 21 meters (its height above the ellipsoid was 48 meters and HAE of the ground was 27 meters), and the reference impact area on the Huan-Dong Blvd was about 20 meters by 10 meters. A scratch mark was found on the road surface, the total length of the scar was about 2.5 meters, and heading was about 60 degrees. Some wreckage debris was found near the impact point on the barrier with reference position N25°3'46.45", E121°37'1.15". The aircraft stroke a light pole, which was very close to the impacted barrier (on the right upper corner of Figure 1.12-1). The distance from the impacted barrier to main wreckage on the river was about 90 meters, and the distance from the impacted taxi to the impacted barrier was about 9 meters.

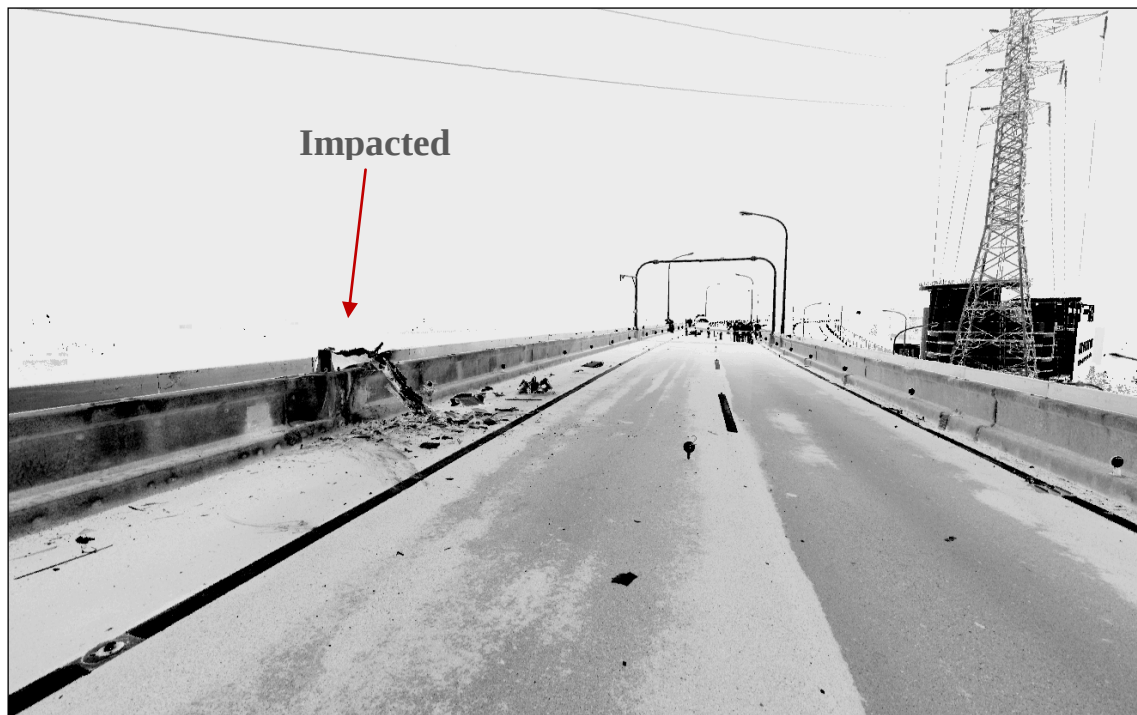
Figure 1.12-4 Perspective view of the point clouds at crash site (Huan-Dong Blvd.)

While ASC was conducting the site survey, the Criminal Investigation Bureau (CIB) performed parallel investigation and utilized its 3D LIDAR on the Huan-Dong Blvd to collect the impact information. CIB scanned the area near the first impact point, and provided ASC the survey result. The LIDAR data was recorded as three-dimensional point clouds. The height of street light were 7 meters, and the width of the Huan-Dong Blvd was 10 meters. There were some electrical power transmission lines above the Huan-Dong Blvd, over 20 meters high. Figure 1.12-4 shows the point clouds of the crash site, and the impacted barrier on the Huan-Dong Blvd was reconstructed by a LIDAR scanner. In addition, the

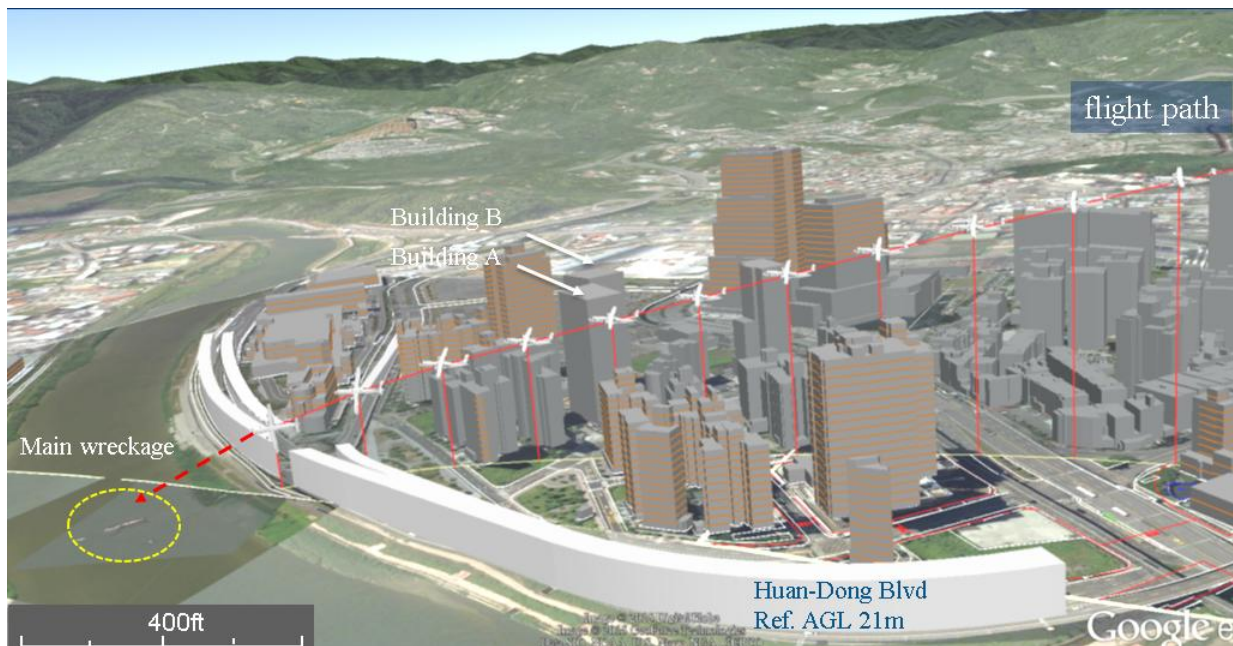
Figure 1.12-6 Perspective View of the crash site, mapping with FDR flight path

ASC a set of precise digital terrain data and aerial photos, and ASC created the surface models of the taxi, part of Huan-Dong Blvd, and street lights. Flight path and related ground building models were illustrated in Google Earth, shown in Figure 1.12-6. There are two building marks (denoted as A and B) equipped with video camera that captured last few moment of the flight, the relevant video frame presented at section 1.12.1.3. Figure 1.12-7 shows an aerial photo of the crash site taken from a rescue helicopter.

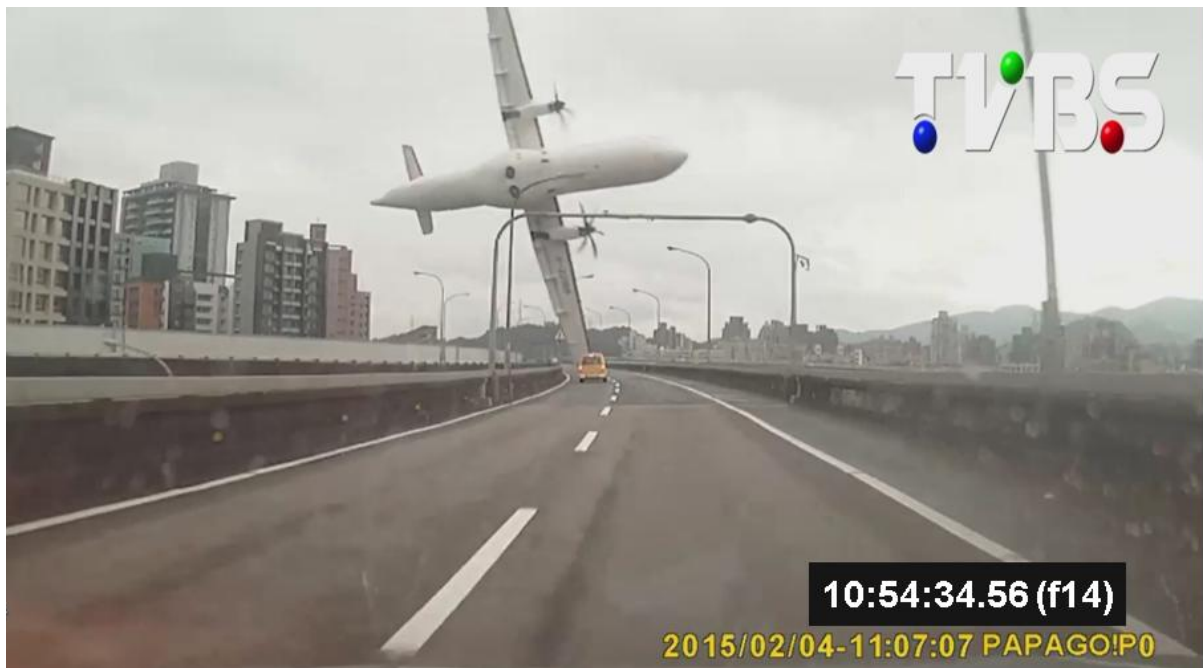
Figure 1.12-9 The 14<sup>th</sup> frame of dashcam videos of the silver car (CVR 1054:34.56 hrs)

After the occurrence, ASC investigators collected traffic surveillance video at Huan-Dong Blvd and several dashcam videos from nearby vehicles. Several videos showed that the aircraft hit a taxi, impacted the viaduct, and then crashed into Keelung River. All videos were examined during the investigation. When the occurrence happened, two ground vehicles (noted as black color and silver color) were traveling westbound on Huan-Dong Blvd. Their dashcam videos contained clear images and were helpful for the investigation. To correlate the time of video and flight recorders, the unidentified sound (1054:34.8 hrs) of CVR before aircraft crash was used to be the common event of the aircraft hitting the taxi and viaduct on the video. Relevant video snapshots of the silver car dashcam with CVR time are shown in Figure 1.12-8, the copyright of video was authorized by TVBS for public publication.

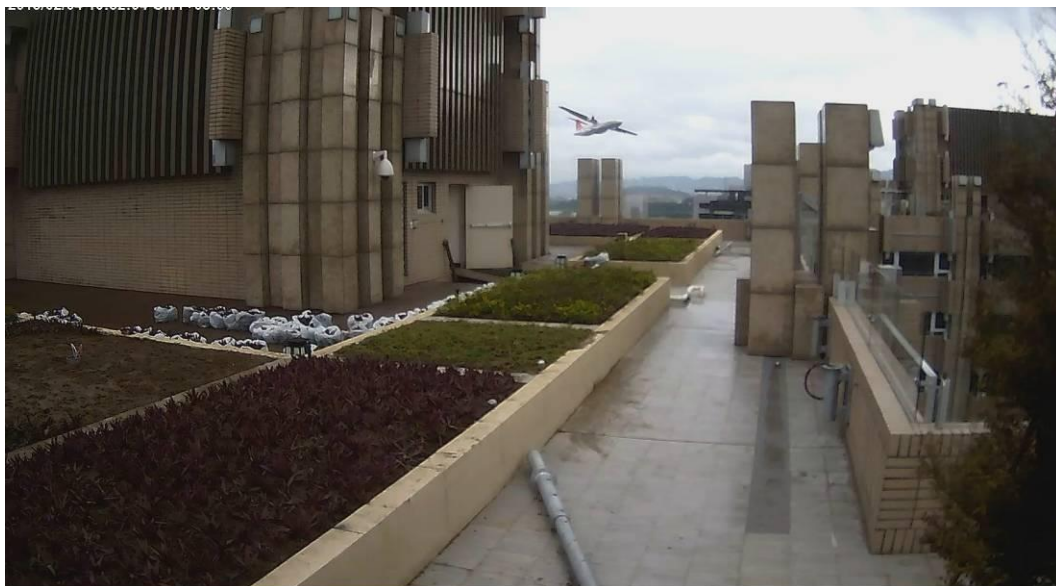
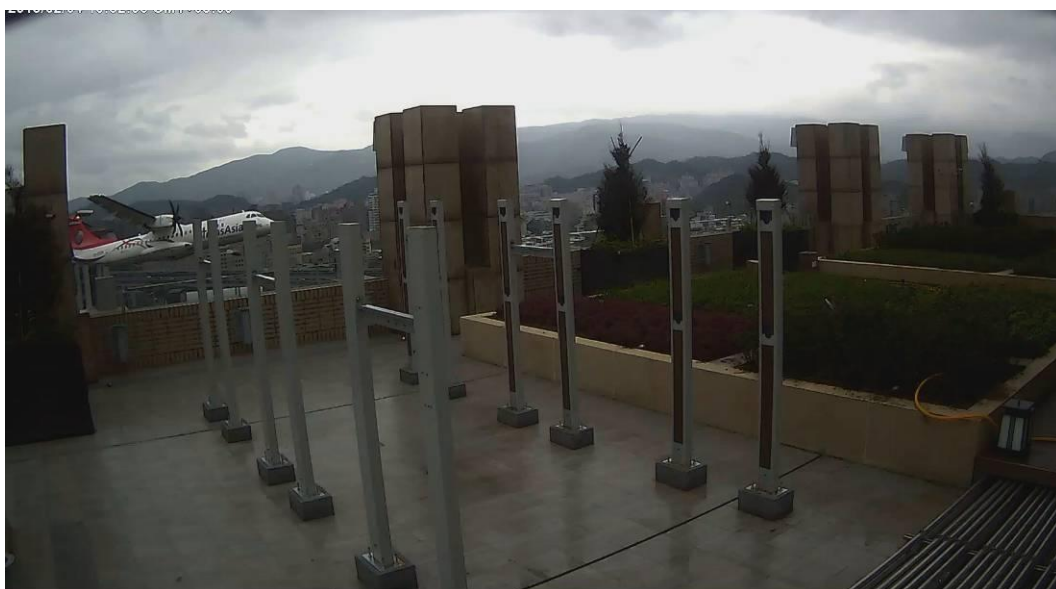
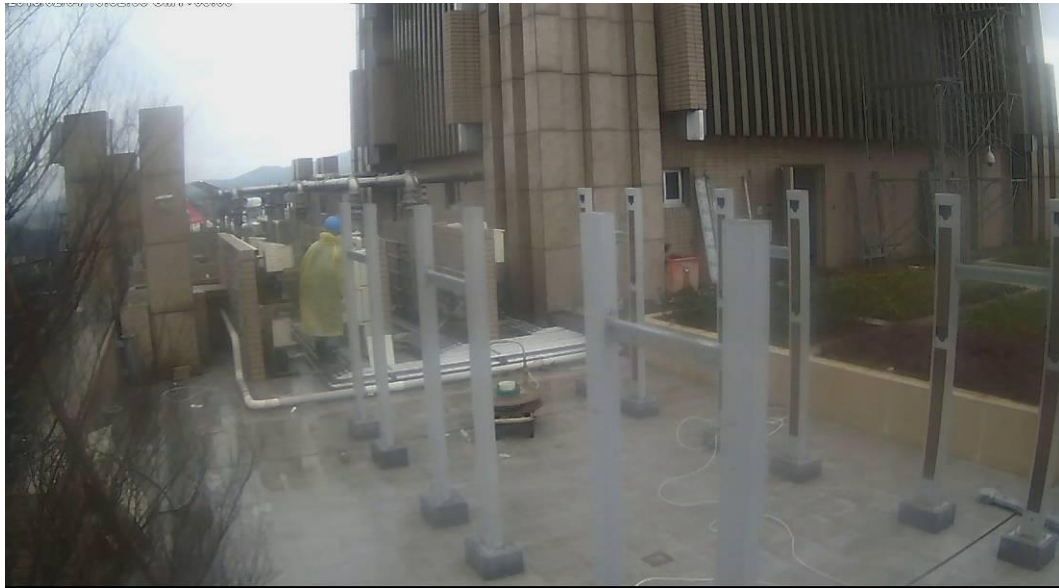
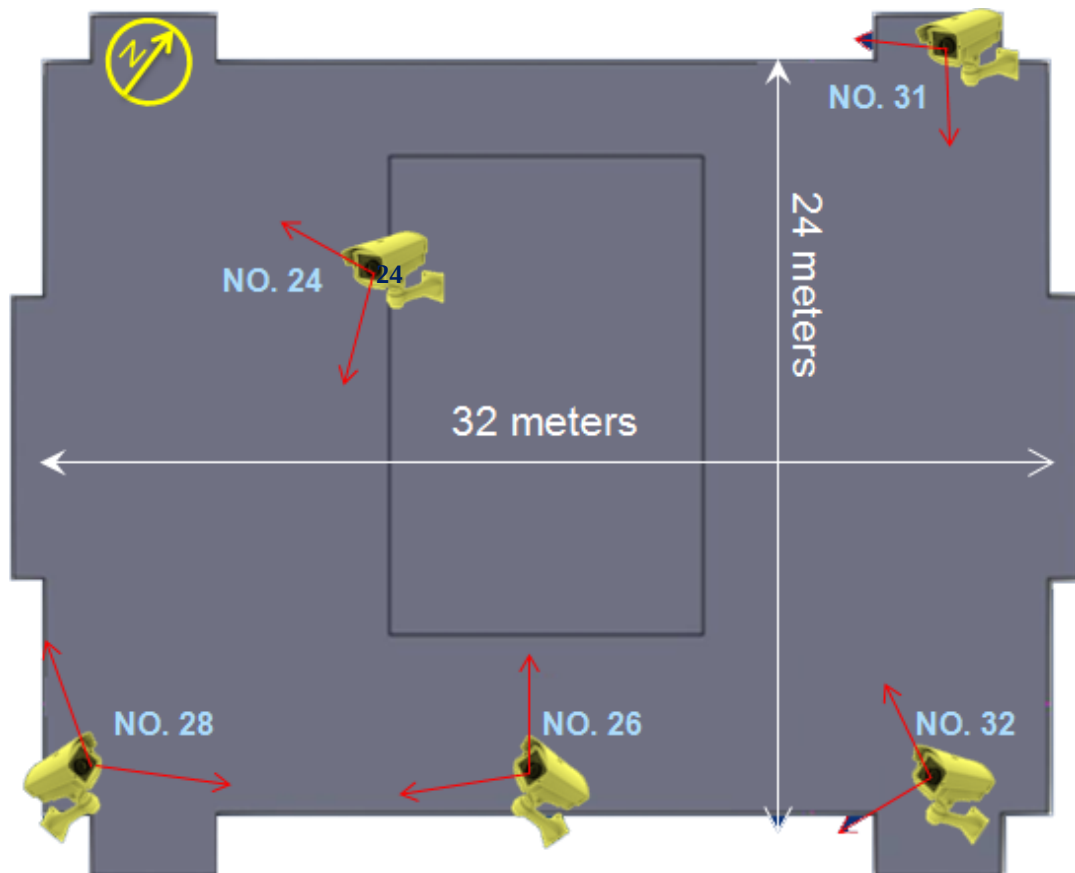
ASC investigators also collected six surveillance videos from the buildings in Jingmao 2nd Rd. Positions of building A and building B are shown in Figure 1.12-6. The videos showed that the aircraft passed near building A before it impacted the Huan-Dong Blvd. Three surveillance video clips were clear, some of video snapshots were shown in Figure 1.12-12 to Figure 1.12-14. Figure 1.12-15 showed surveillance videos location at the roof of building A and the flight path was on its western side. The height above ground of building A was 74 meters. The HAE at the roof of building A was 107 meters, and the HAE on ground near building A was 33 meters.
